Fatality Assessment and Control Evaluation (FACE) Pr

26-Year-Old Emergency Medical Technician Dies in Multiple Fatality Ambulance Crash - Kentucky

NIOSH In-house FACE Report 2001-11

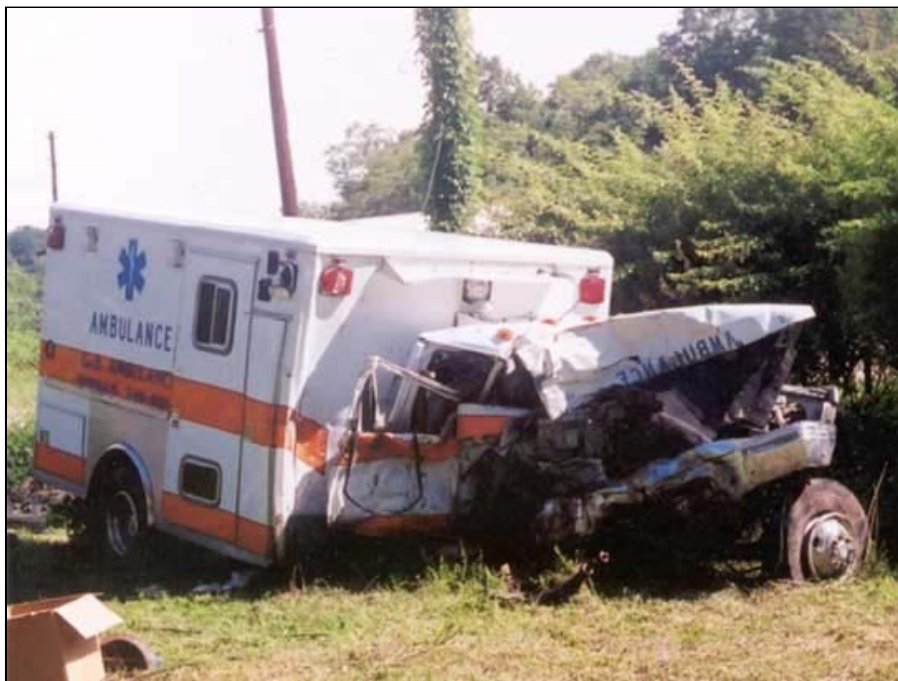
Photo 1. Type I ambulance at employer's vehicle yard after recovery from crash site.

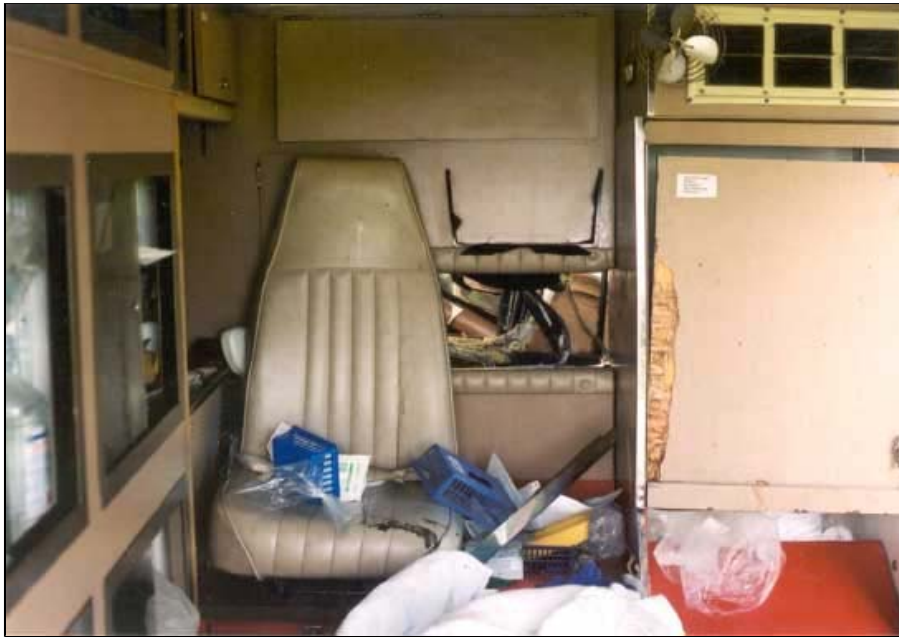
Discussion: During the collision, the patient was ejected from the cot and came to rest head-down on top of the EMT after striking the front bulkhead. The cot involved in the incident was equipped with lap-belt type restraints located to cross the patient just below the pelvis and across the legs. Cot manufacturers currently make available cots equipped with four-point restraints for the patient's upper body in addition to the two lower-body restraints (Photo 6). Employers and operators of ambulance services should consider equipping their ambulance fleets with this type of cot. As evidenced by this incident, belt restraints across the patient's body offer little or no resistance to forward movement induced from frontal collision. Had the patient been restrained with shoulder belts, her injuries may have been minimized. Additionally, it should be noted that during a crash, secondary collisions between unrestrained occupants in the patient compartment may also be a source of significant injury.

Photo 2. Front bulkhead of patient compartment.

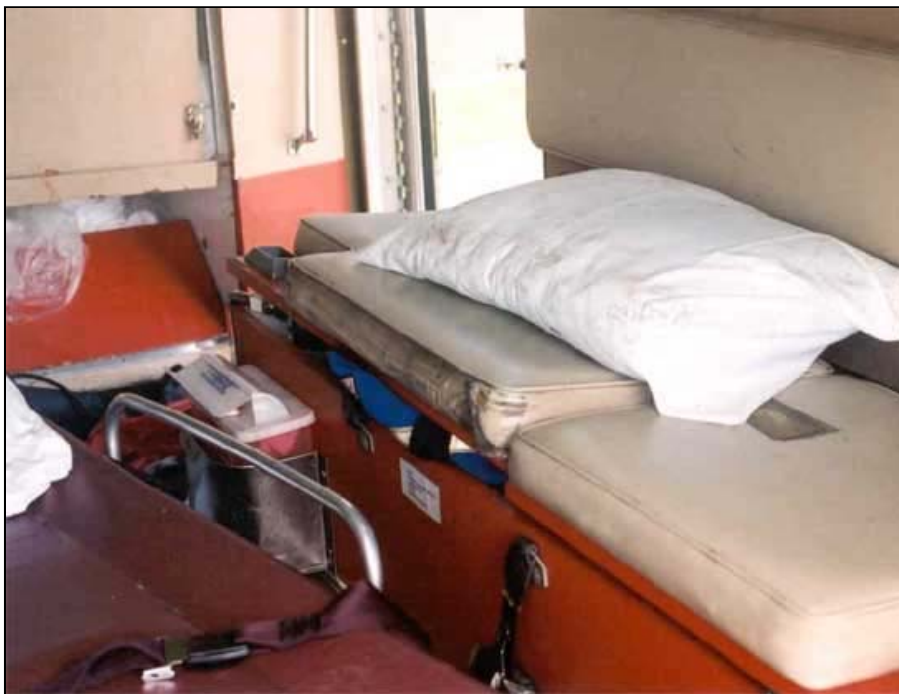
Discussion: The patient compartment of the ambulance involved in this incident was configured with four seating positions, each equipped with two-point lap-belt restraints. These positions included a rear-facing, high-backed captain's chair and a squad bench with accommodation for three persons (Photo 3). The employer's written policies contained procedures for transporting family members or other appropriate passengers that required them to ride restrained at the head of the cot in the captain's seat. However, the program did not address restraint use by EMTs working in the patient compartment. Reportedly, the victim's normal routine was to occupy the squad bench while working in the patient compartment. In this position, she had good access to the patient and the patient could see her. Elderly patients often become anxious if they cannot see the attendant. It should be noted that the lap-belt restraint systems commonly used in ambulances do not allow full access to the patient during treatment for all conditions. When properly used, the squad bench lap belts position the occupant against the side wall in such a manner that the EMT cannot bend forward to access the patient. If the EMT needs to access the cabinets along the street-side wall, the belts must be unbuckled to allow the EMT to stand up. Additionally, if it is necessary to perform CPR or other procedures such as intubation or insertion of IVs, the EMT may need to stand over or kneel near the cot. For these reasons, it may be common practice among EMTs to ride unrestrained, seated on the edge of the squad bench. However, during non emergency transport, EMTs could remain seated and restrained in the captain's chair or, alternatively, the EMT could be seated restrained on the squad bench. Because force magnitude estimates for this crash were not available, the degree of protection for the victim had restraints been used could not be evaluated. Had restraints been used, the EMT would most likely have been held in place on the squad bench and not have impacted against the front bulkhead during the collision. Her injuries may have been minimized. The ambulance cab was severely damaged during the collision; however, the patient compartment suffered very little damage (Photos 4 and 5). Had the victim been seated and restrained in the rear-facing captain's seat, her injuries may have been less severe.

Photo 3. Squad bench, location of the victim just prior to crash.

Recommendation #1: Employers should ensure that emergency service workers use the patient compartment vehicle occupant restraints whenever possible.

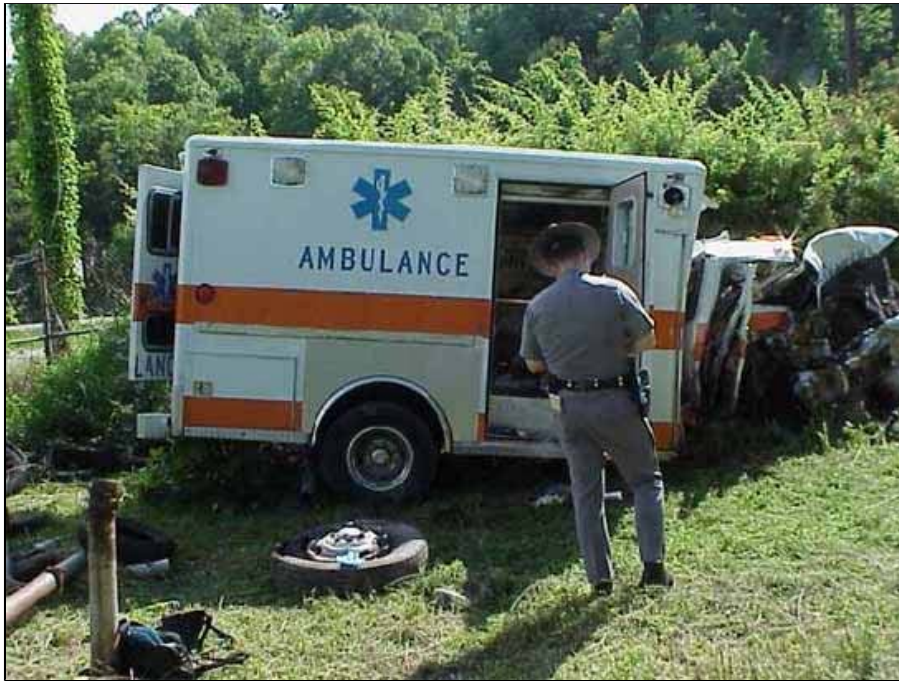
Photo 4. Driver's cab and patient compartment. Note minimal damage to compartment.

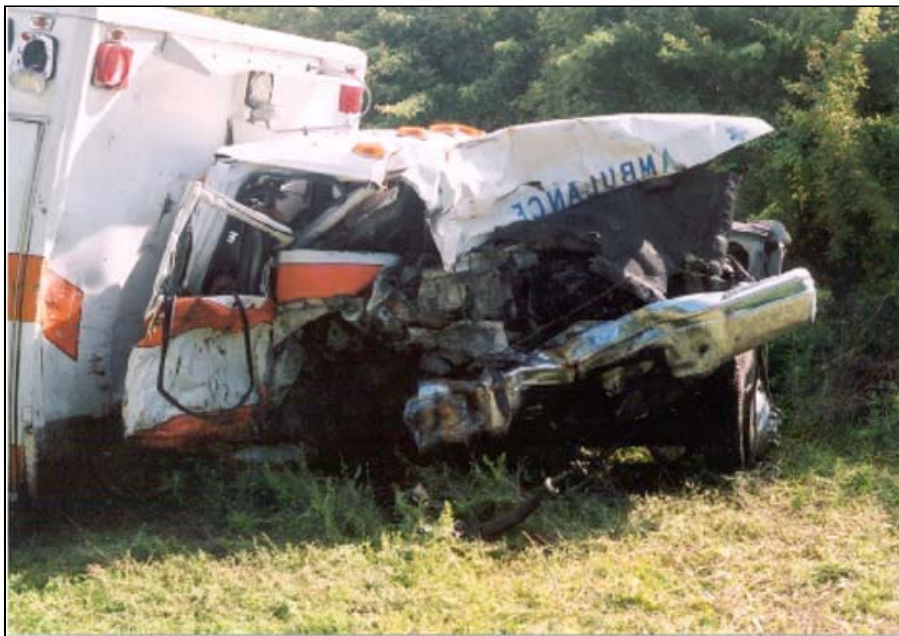
Discussion: The ambulance involved in this incident was equipped with lap-belt restraints for the driver and front-seat passenger. At the time of the collision, the paramedic was driving unrestrained. Although the paramedic recovered from his injuries, they may have been minimized if the occupant restraints had been used. Studies have shown that for light-truck occupants, the use of restraints reduces the risk of fatal injury by 60% and the risk of moderate-to-critical injury by 65%.¹

Photo 5. Damage to driver's cab.

Recommendation #3: Employers should ensure that drivers and front-seat passengers of emergency service vehicles use the vehicle occupant restraints provided.

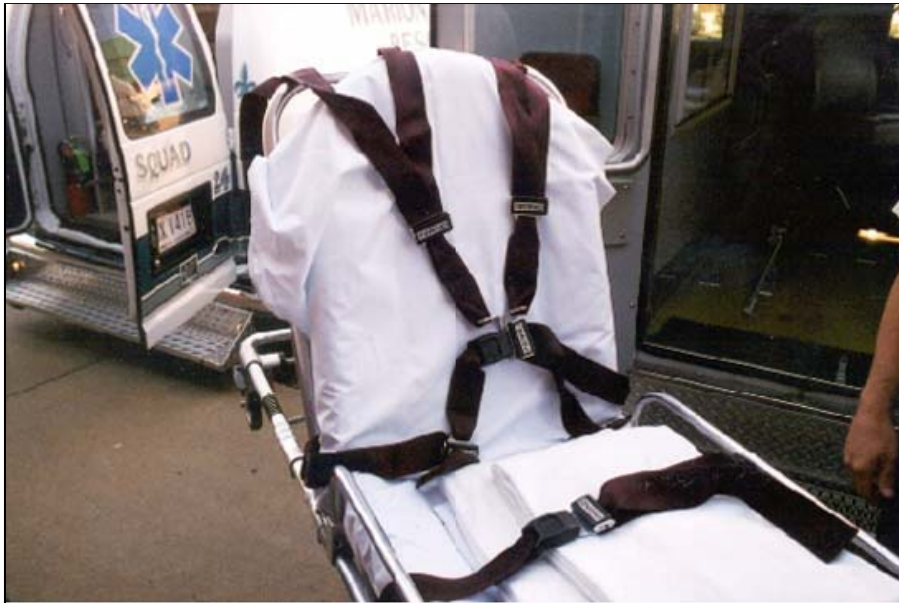
Photo 6. Patient cot equipped with four-point upper-body restraint.

Recommendation #2: Employers should consider equipping ambulances with patient cots that include upper-body restraints.
