FIRE RESEARCH AND DEVELOPMENT TECHNICAL REPORT

Considerations for Fire Service Response to Residential Battery Energy Storage System Incidents

December 4, 2023

Prepared for the International Association of Fire Fighters

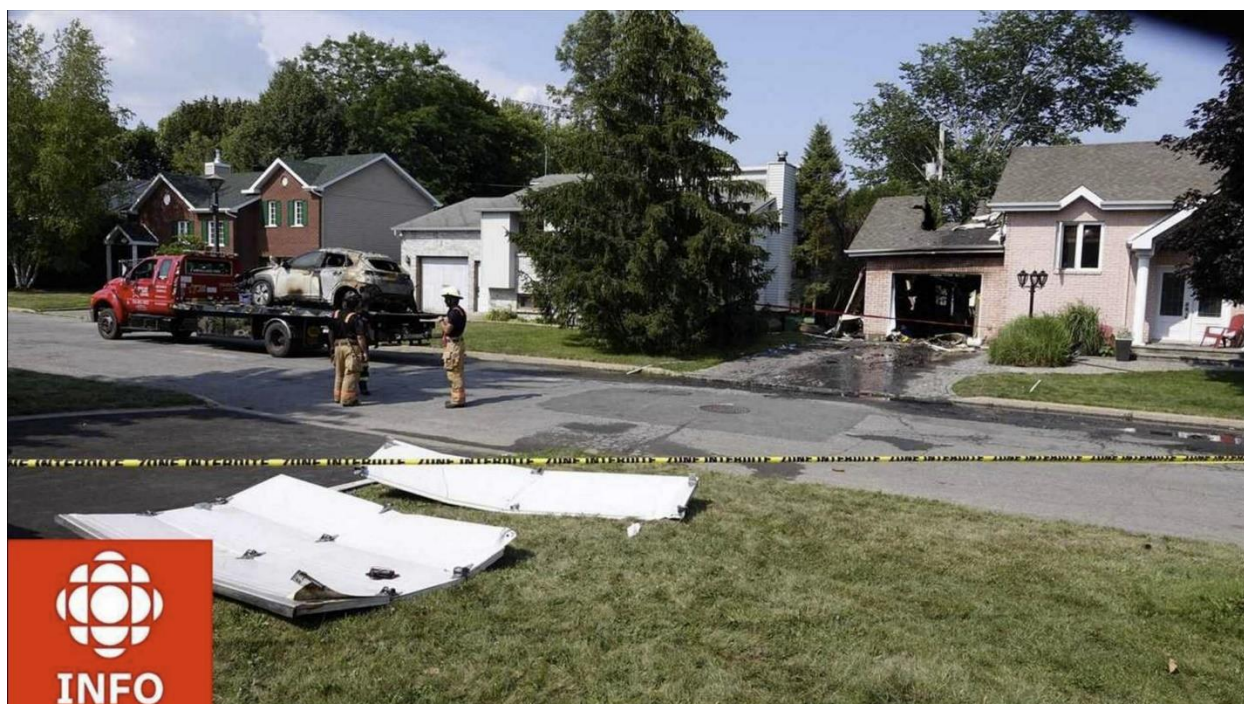
On July 27, 2019 a Hyundai Kona was parked in a residential garage in Île-Bizard, Montreal, Canada when it caught fire and later caused an explosion [19]. The car was purchased in March 2019 and was not plugged in according to the owner. He called the fire service at 1 pm after seeing dark smoke coming from the closed garage and turning off the breaker to the garage. No one was injured but the owner said “If we were in front of the garage door, we could have been in the hospital.” The fire service reported that they could find no other sources inside the garage besides the car that could have caused the explosion. Figure 12 shows the position of the garage door as encountered upon arrival of the first due engine company.

Figure 12 – Garage condition following incident [19].

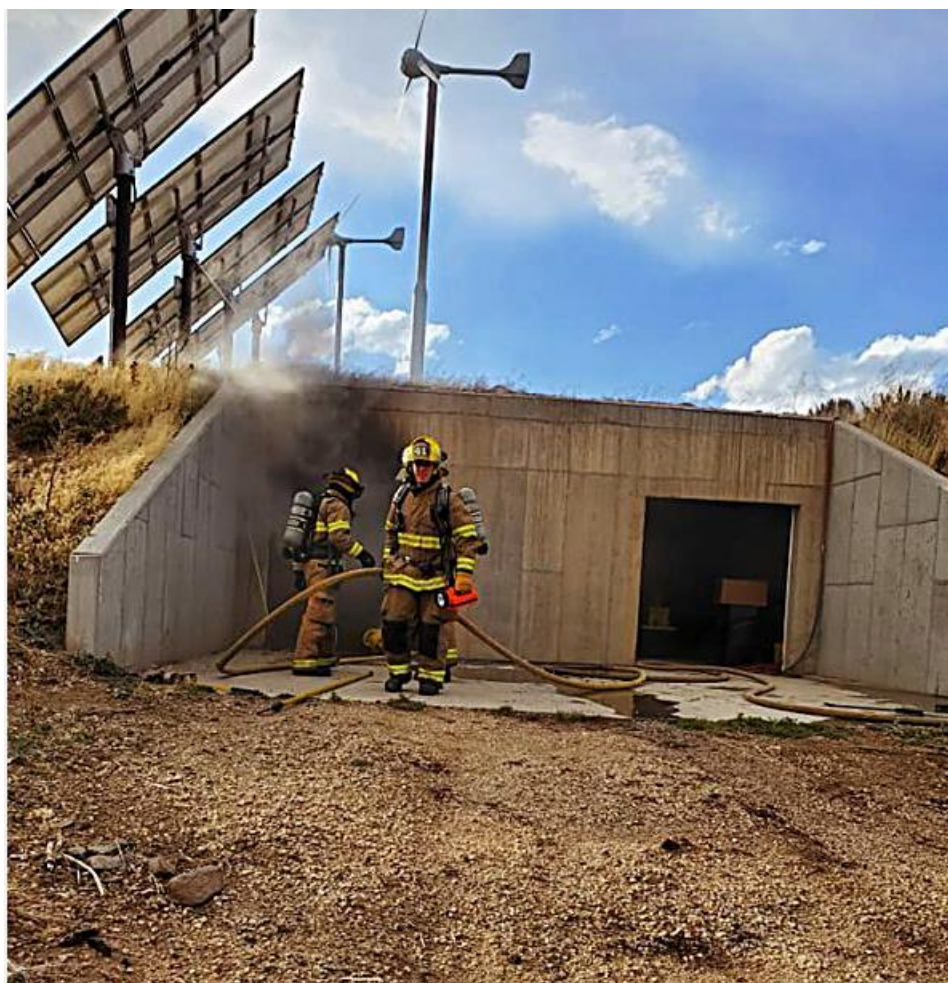
October 2, 2019 a fire broke out in a concrete bunker that contained the ESS for a residential solar and wind system. When the fire department arrived, black smoke was pouring out of the bunker around the metal garage door [20]. The batteries were in the back of the bunker (approximately 15 or 20 feet from the door) and the fire service used foam to extinguish the fire. No one was injured and the damage was confined to the bunker. Figure 13 is a photograph of the bunker ESS installation.

Figure 13 – Concrete bunker where ESS incident occurred [20].

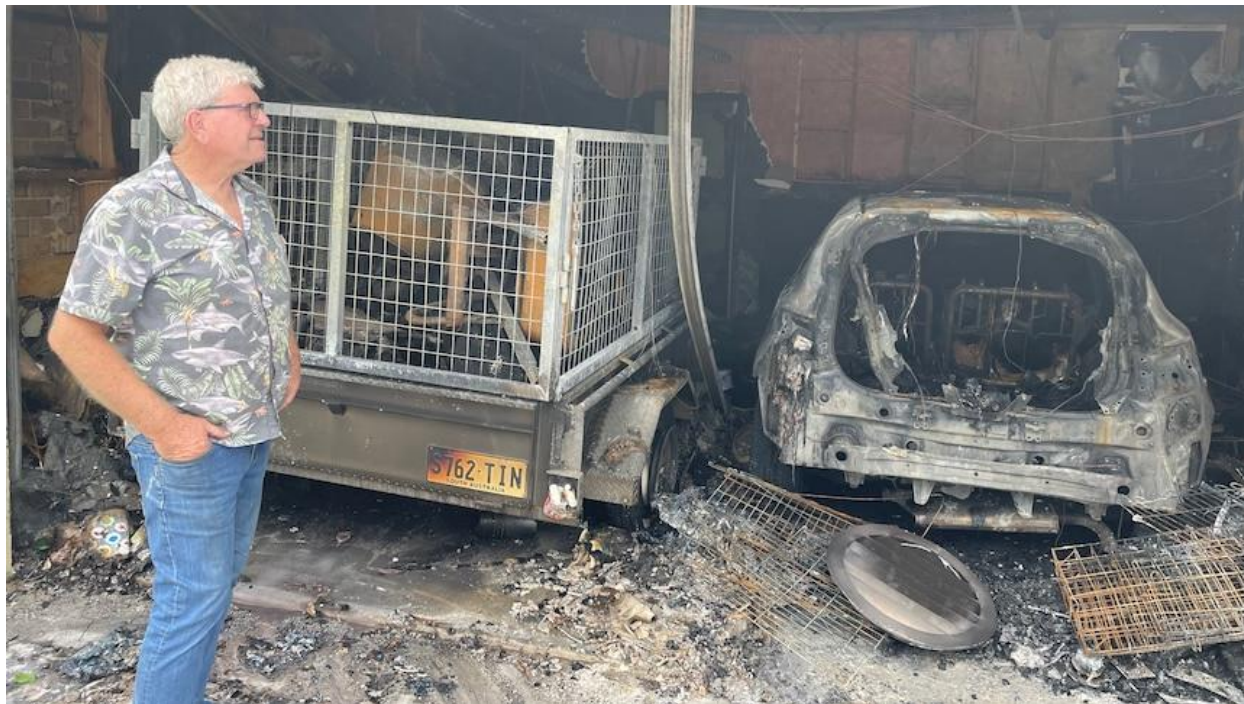
A resident of Burton, a suburb of Adelaide, was woken at 3 am on February 12, 2022 by his smoke alarm and bangs coming from the roof of his house. He called the fire service and then evacuated the house with the other residents. The fire started in the ESS for the solar system which was in the garage. No one was injured but the damage is estimated at \$200,000 AUD and the garage is a total loss [21]. Damages are shown in Figure 14.

Figure 14 – Aftermath of Adelaide incident [21].

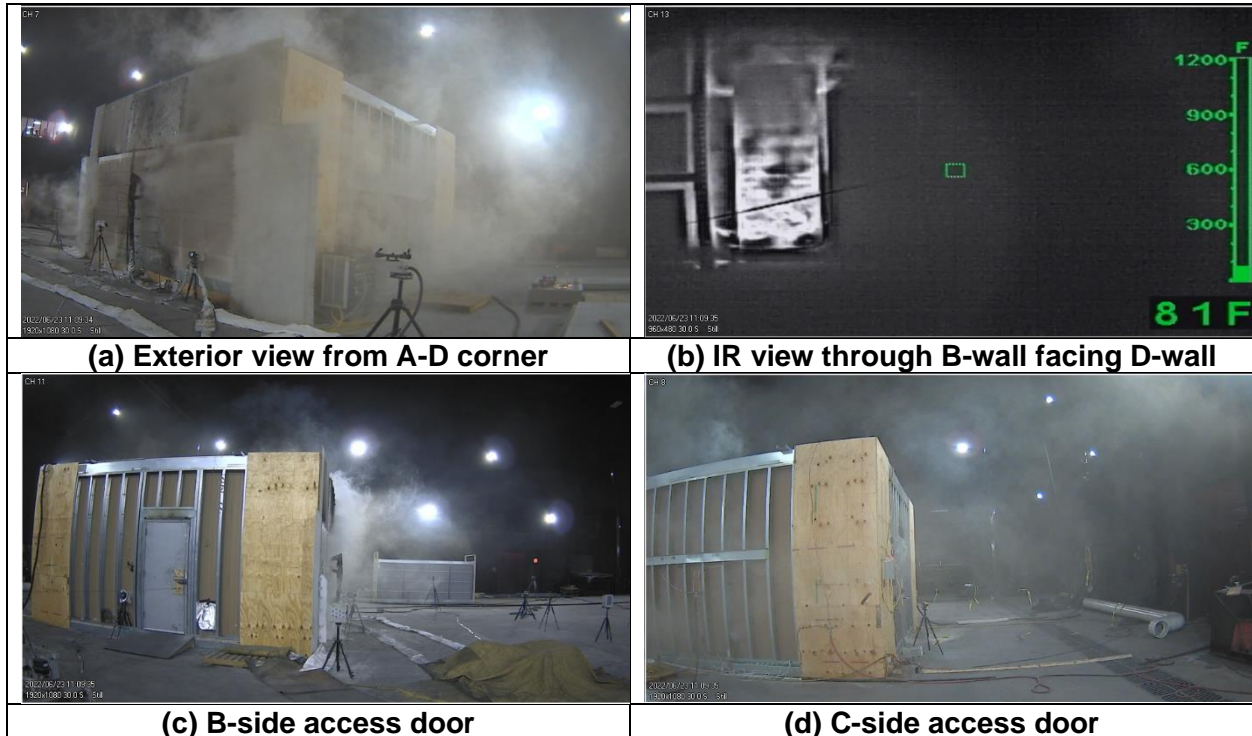
Figure 108 shows four views immediately prior to the deflagration. Interior IR views indicate active thermal runaway but do not provide an indication of the flammability of the environment or likelihood of the deflagration. Exterior images show significant gas leakage from around the garage door and roof of the structure. The buoyancy driven gases emit around all seams and kerfs of the garage door. The gases, which are battery thermal runaway effluent, appear light gray to white and are not distinct from ventilation-limited fire smoke. Traces of battery gas are visible around the seams of the C-side access door. No evidence of smoke is visible around the perimeter of the B-side access door.

Figure 108 – Visual conditions immediately prior to deflagration (36:26, TR + 15:56).

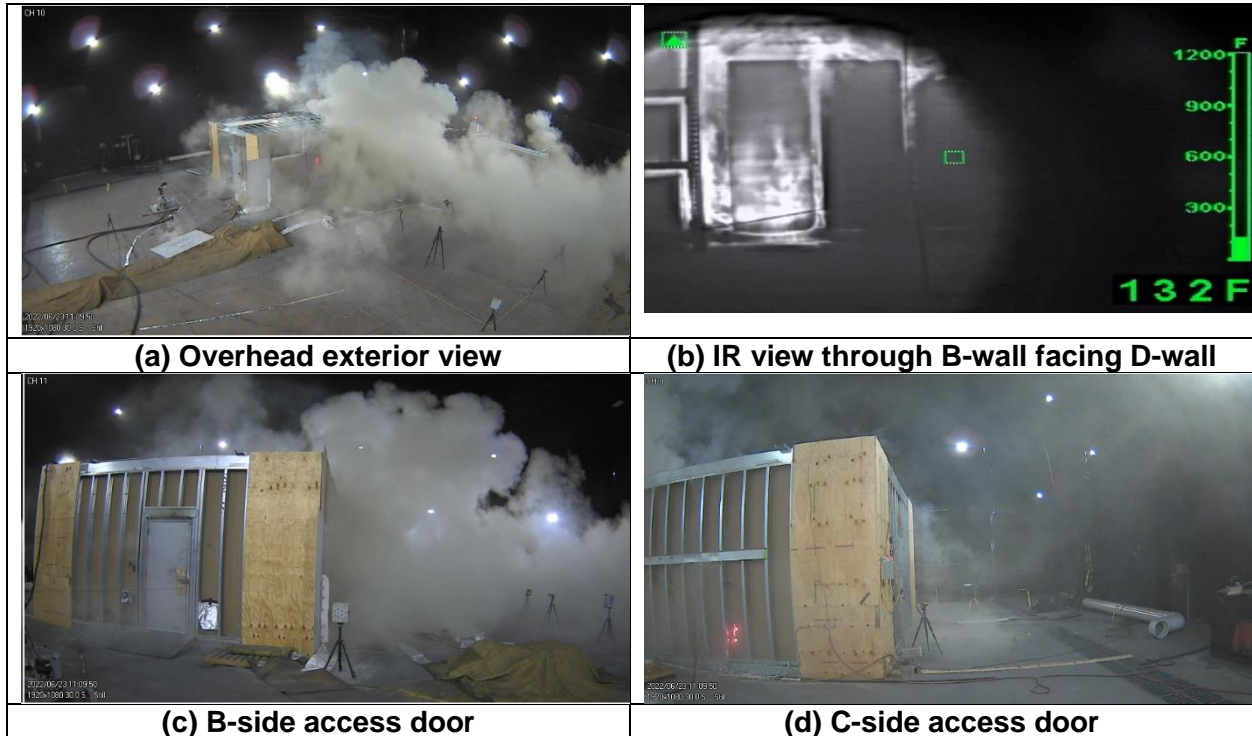
Figure 109 shows the environment of the garage 10 seconds after the deflagration. Interior IR imaging shows active thermal runaway activity with surrounding flaming. Exterior views show a significant cloud of gases, vapors and smoke pushed 60-70 ft across the lab. The quantity and positioning of vapor clouds could indicate to a firefighter that a deflagration has recently occurred, and that the situation requires added precautions. Even though the garage door damage was limited, the surrounding environment indicates the occurrence of a deflagration event. Additionally, flaming is visible in penetrations on the D-side wall and small amounts of battery gas is visible around the perimeters of both the B-side and C-side access doors.

Figure 109 – Conditions 10 seconds after deflagration (36:36, TR + 16:06).

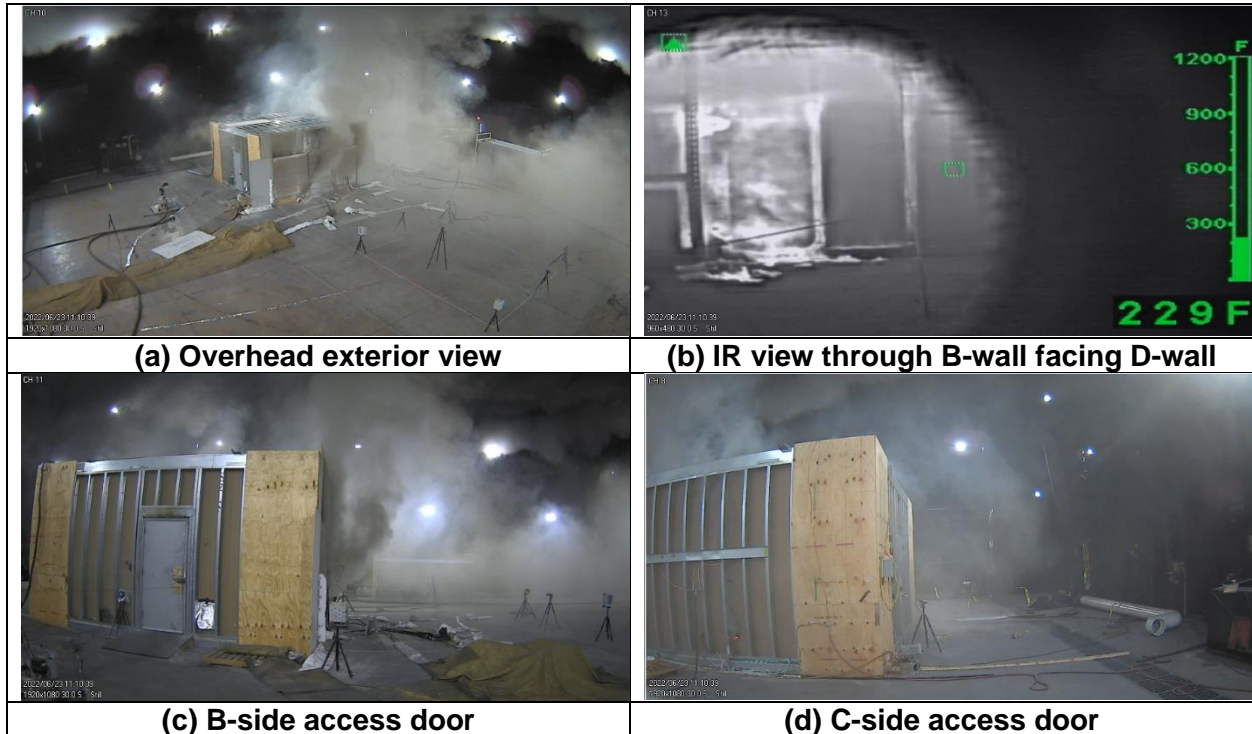
Figure 110 shows the environment one minute after the deflagration occurred. Interior IR views indicate thermal runaway activity in Unit 1 with flaming combustion of the surrounding commodity boxes. At this point, the battery gas originally pushed from the garage is starting to dissipate. The smoke emanating from the gaps in and around the garage door is at elevated temperature because of the interior fire environment. The smoke is buoyancy driven, light gray in color, and does not provide clear indication of battery involvement. Small amounts of smoke are visible at the upper seams of the B-side and C-side access doors. A smoke plume is starting to emerge from the garage door ventilation opening.

Figure 110 – Conditions 1 minute after deflagration (37:26, TR + 16:56).

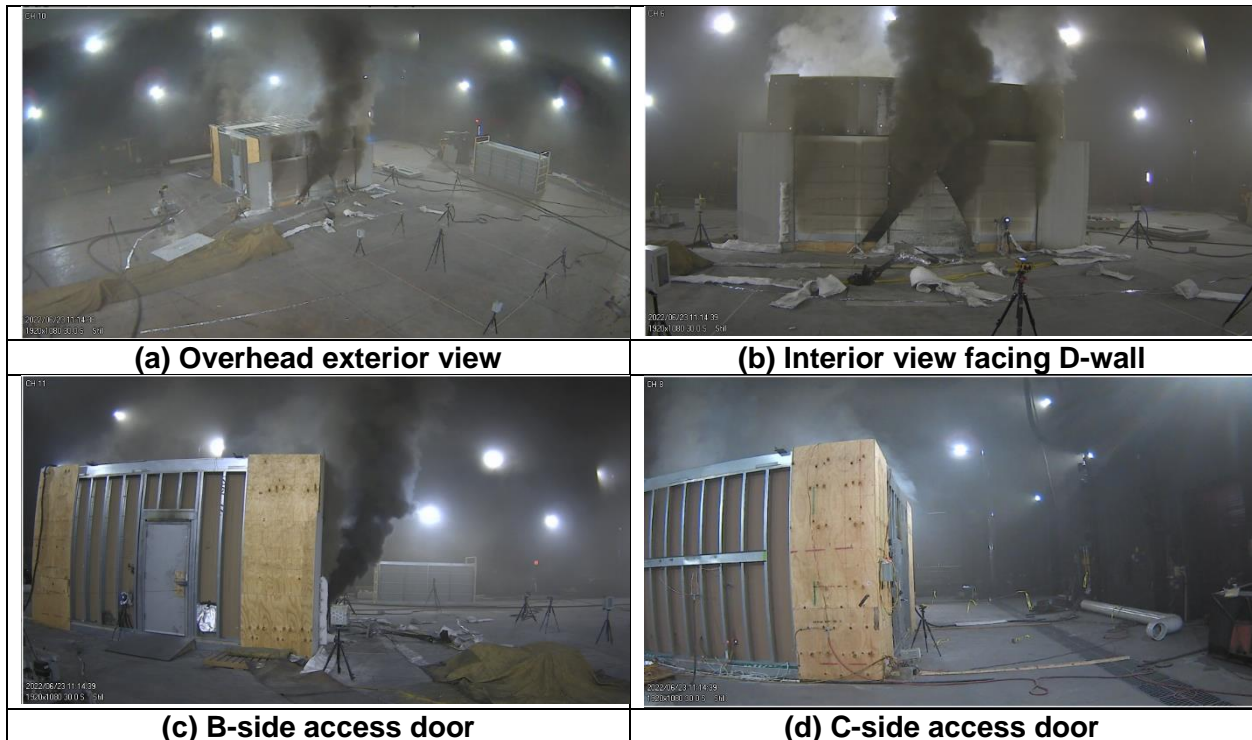
Figure 111 shows the environment around the garage five minutes after the deflagration occurred. At this point, all interior camera views, including IR, are obscured by smoke and provide no differentiation between objects or temperatures throughout the interior. Exterior visuals indicate fire growth inside the garage. The light gray smoke shown in Figure 110 has darkened with the addition of soot from the growing fire. The smoke is driven upwards by the buoyancy of the plume and does not provide a visual suggestion of battery involvement. The exterior smoke from the deflagration is no longer visible. Traces of smoke are visible at the upper edge of the B-side and C-side access doors, which could provide evidence of fire in the garage to an attached structure. The quantity of smoke from the access doors does not provide a reliable indicator of fire size or ventilation conditions.

Figure 111 – Conditions 5 minutes after deflagration (41:26, TR + 20:56).

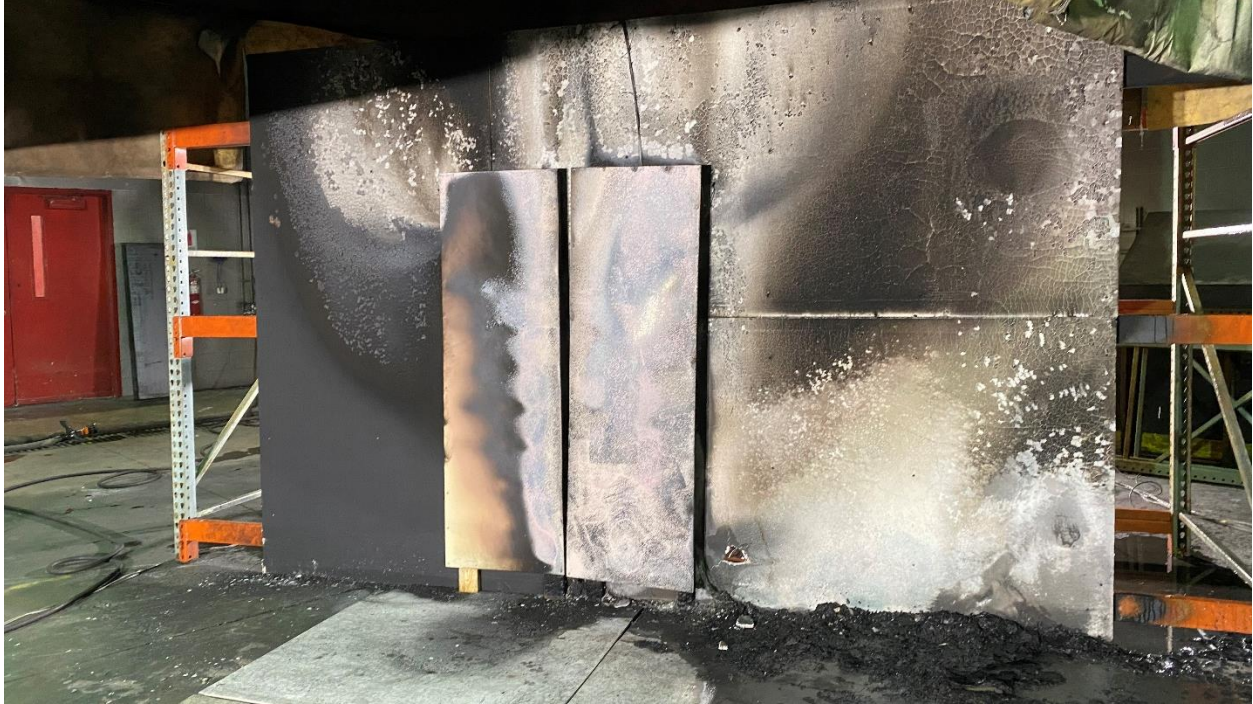
Figure 195 – Post-test condition of ESS units and Commodity boxes in Scenario 1.

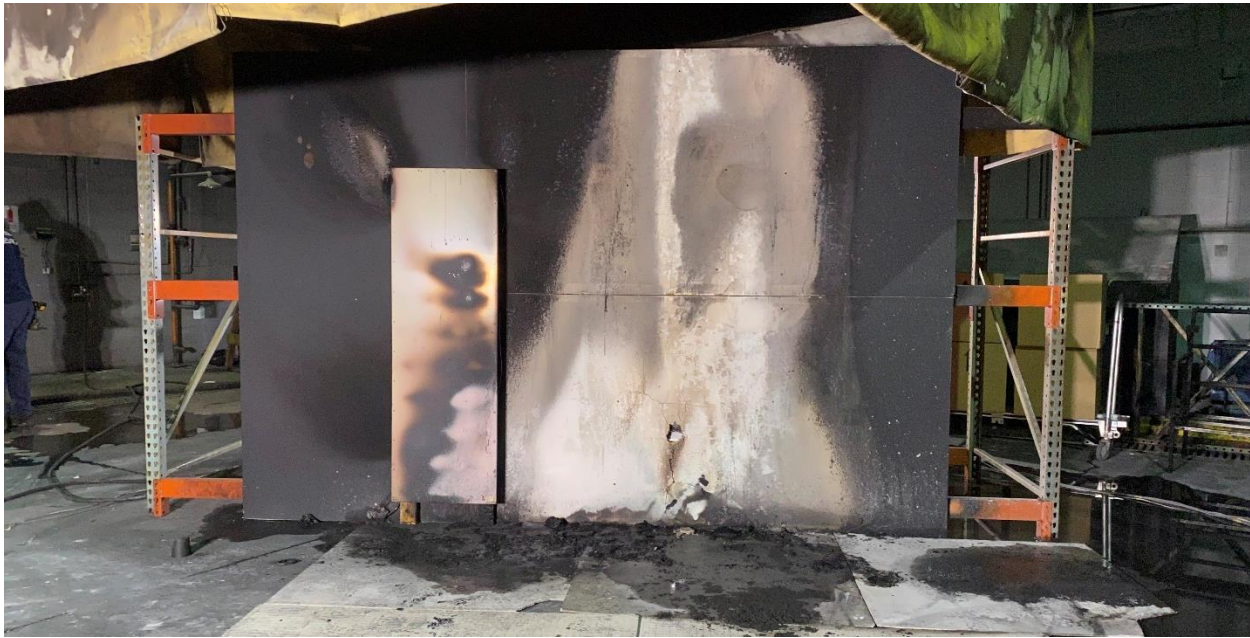
Figure 199 – Post-test condition of ESS unit and Commodity boxes in Scenario 2.
