WORKPLACE SOLUTIONS

Preventing Deaths and Injuries to Firefighters Working at Strip Mall Fires

DHHS (NIOSH) Publication No. 2023-126

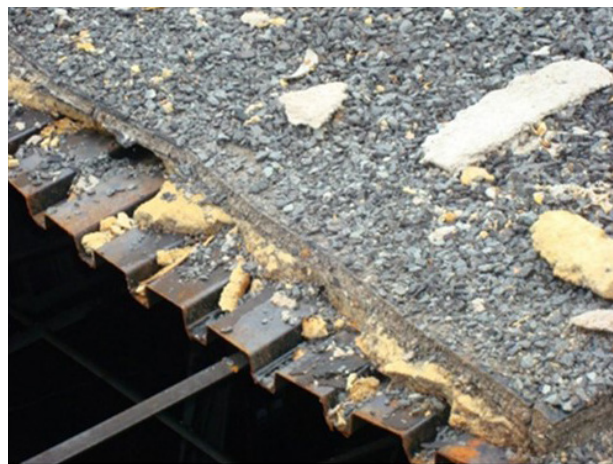
The ladder company had difficulty cutting through the flat metal roof due to the composition of the roof. They unsuccessfully tried to ventilate the roof using a chainsaw and had to switch to a circular saw with a metal cutting blade. (See **Photo 1**).

Photo 1. Construction of flat metal roof covered with asphalt foam insulation, and gravel. Chain saws were initially used to open the roof for vertical ventilation but would not cut through the metal deck. A circular saw with metal cutting blade had to be used.
