FIRE RESEARCH AND DEVELOPMENT TECHNICAL REPORT

Considerations for Fire Service Response to Residential Battery Energy Storage System Incidents

December 4, 2023

Prepared for the International Association of Fire Fighters

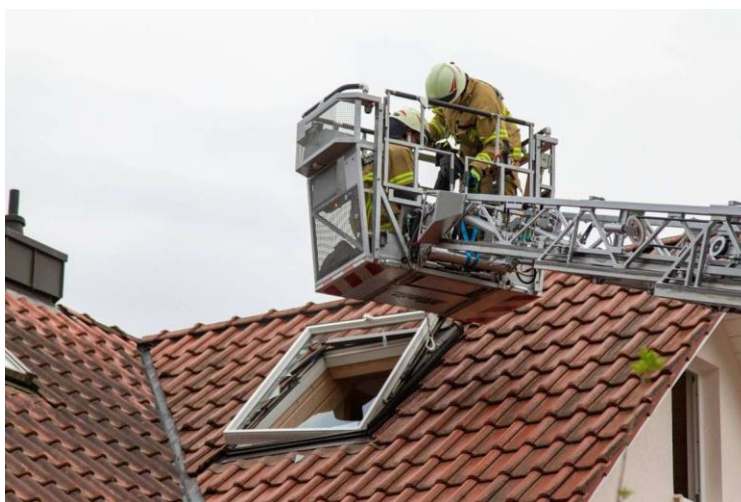
At approximately 5:20 pm a woman reported a fire in the basement of a house in the Coburg area. The fire service was able to bring the fire under control, but an explosion occurred during this process. The source of the fire was later identified as a technical defect in the ESS of a solar system. The two residents had initially attempted to fight the fire themselves and were later taken to the hospital for smoke inhalation [16]. Figure 9 shows some of the damage following the explosion and fire fighter operations.

Figure 9 – Damage to window during incident [16].

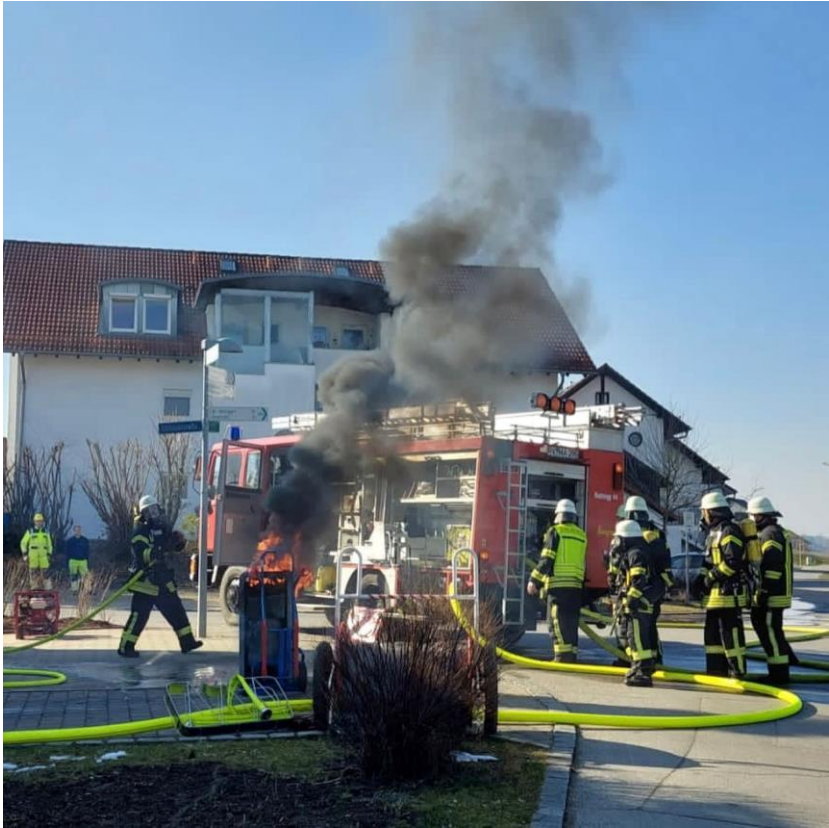
According to police investigation, at around 2 pm the ESS of a solar system exploded in the basement of a house in Bodnegg, Germany. The cause is suspected to be a technical defect in the system. The explosion was strong enough to push out several doors and windows and to lift the entire roof structure. No one was injured but the building was rendered uninhabitable with an estimated €250,000 of damages. The fire service sent five vehicles and 30 firefighters to fight the fire [17]. A technician from the local electrical utility service came to switch off power to the building and a master electrician pulled the fuses allowing the fire service to remove the ESS from the house. According to the fire service, the system reignited as it was brought outside and it was finally extinguished and put in a tank of water to cool it down and prevent further reignition [11]. This sequence of events is shown in Figure 10 and Figure 11.

Figure 10 – Burning ESS after removal from residence [17].

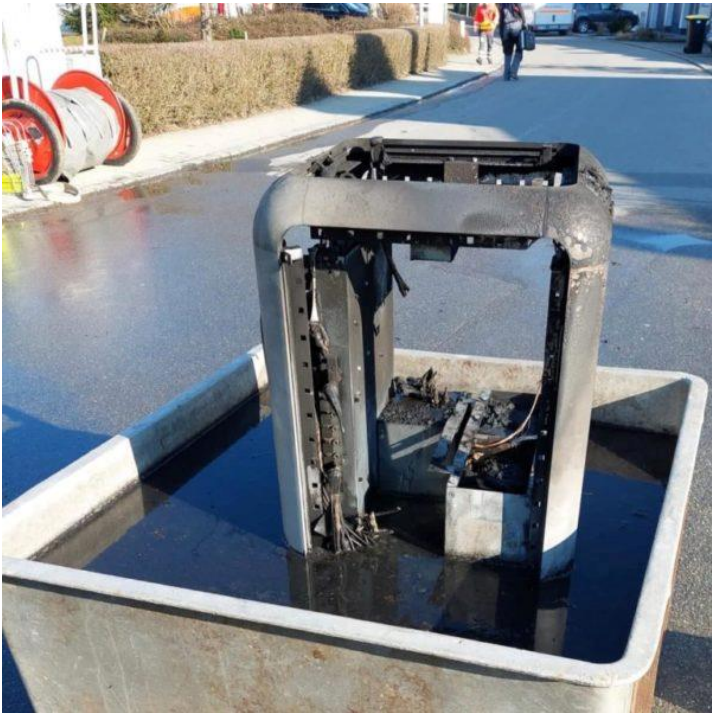
Figure 11 – ESS unit condition after firefighting operations [11].

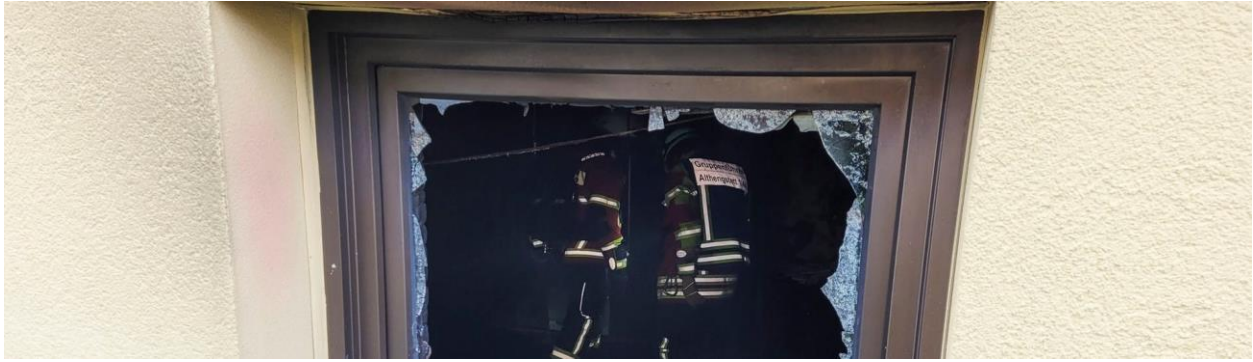
On May 9, 2022, the fire service was called due to reports of white smoke coming out of a house's basement where an ESS for a solar system was located. An explosion occurred shortly before the fire service arrived. The explosion blew out the basement windows and doors, and the doors in the house as well. No one was injured but the damages are estimated at €400,000 to €500,000 and the house is uninhabitable [23]. The fire operations manager said, "I'm so glad the explosion happened before my attack squads entered the house. I can't imagine what could have happened there." The fire was brought under control and the remains of the ESS were submerged in water to cool it and prevent reignition. A sequence of key images is shown in Figure 15 - Figure 17.

Figure 15 – Window damaged by explosion [23].

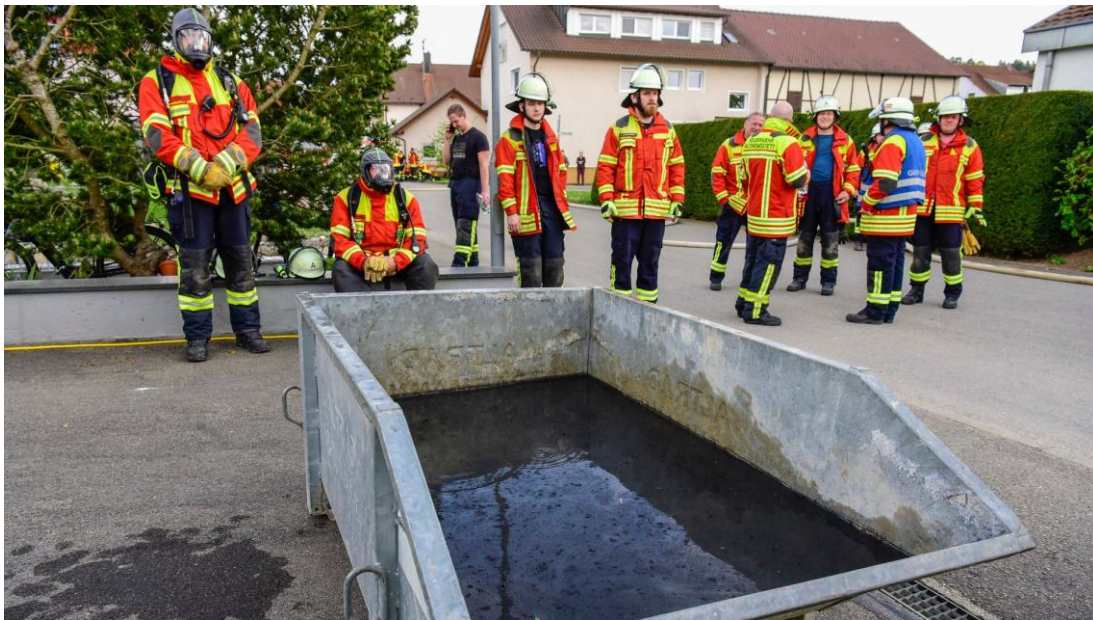
Figure 16 – Fire service responding to incident [23].

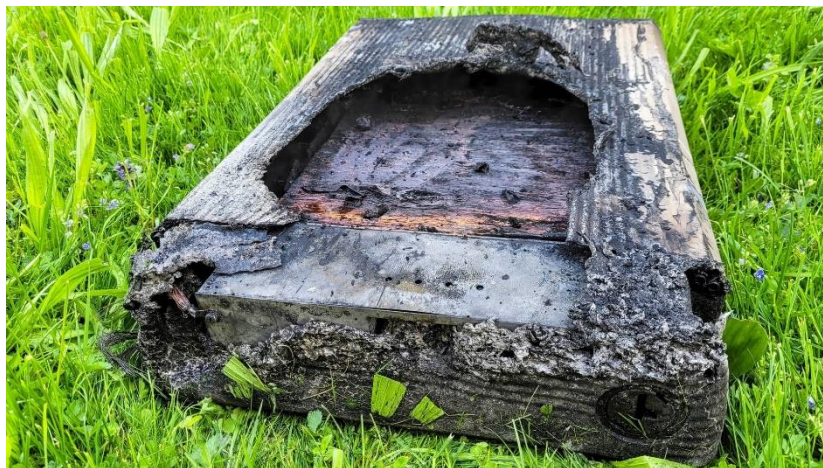
Figure 17 – Battery condition following incident [23].

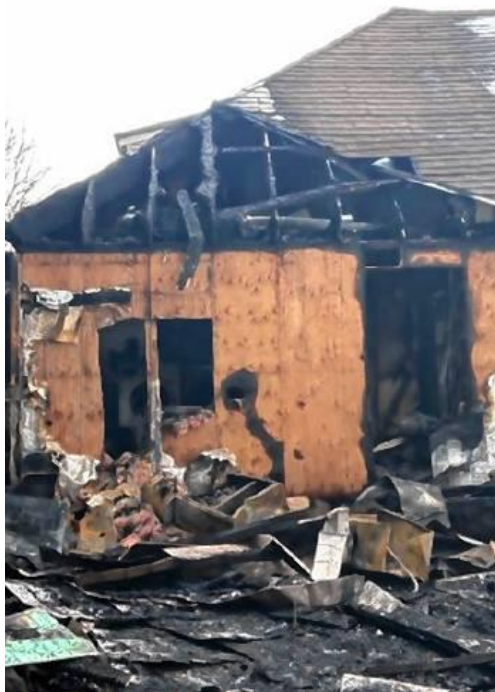
On Saturday, December 17, 2022, one woman was injured in a fire resulting from a battery backup system that was utilized during a power outage. The battery system was installed in a mechanical room and constructed from three used lithium-ion batteries repurposed from Chevy Volt cars [24]. When the homeowner investigated a “popping” sound, she described the battery as “bubbling over” and when she returned with a fan, the battery was on fire with flame extension to the ceiling, at which point the local fire department was called. Figure 18 is a photograph of the incident after the fire.

Figure 18 – Fire damage to property following lithium ion battery thermal runaway [24].

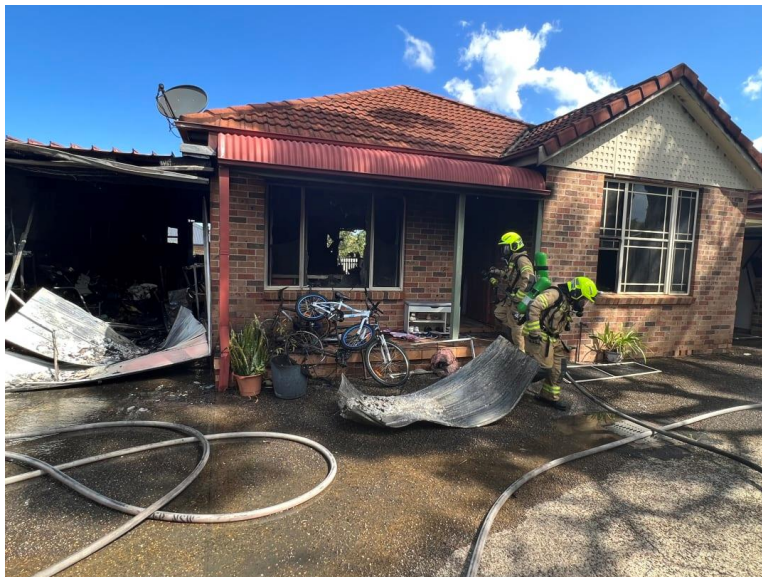
A fire on 15 February 2023 in Epping, Sydney, Australia was found to be caused by a faulty li-ion battery by Fire and Rescue New South Wales. No one was injured but the house experienced significant damage. This incident highlights the challenges of second-life batteries in residential ESS systems due to the unknown history of the battery and how that affects the probability of it experiencing thermal runaway [25]. Figure 19 shows the condition of the home after the fire.

Figure 19 – Conditions after fire caused by residential ESS [25].

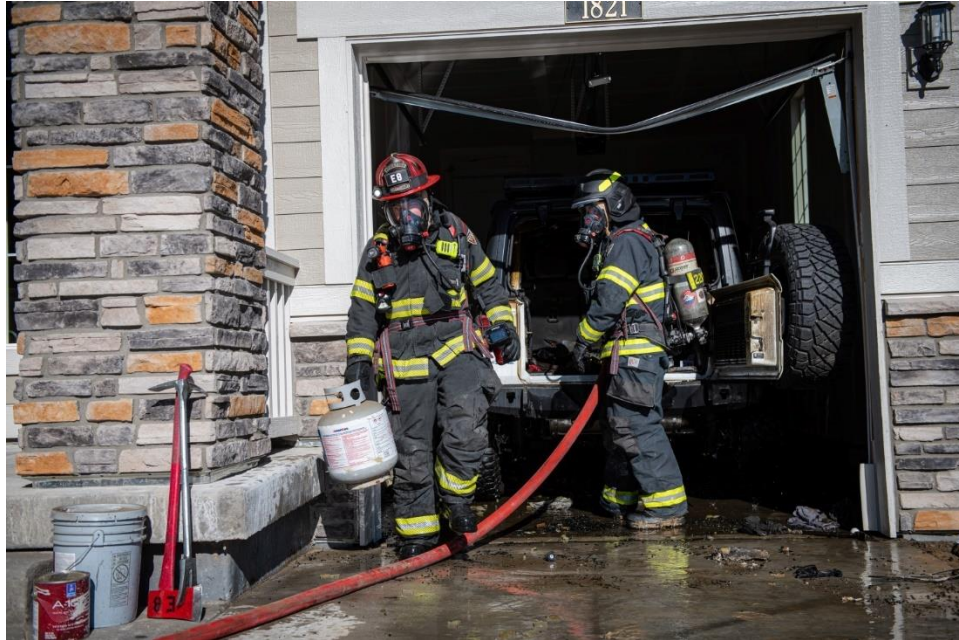
On the morning of April 11, 2023, Mountain View Fire Rescue responded to a reported structure fire. There was no smoke showing at the time the crews arrived. Firefighters searched the first floor of the home to identify the source of the smoke. Smoke was found to be coming from the secondary garage. Within the garage, a Jeep Wrangler 4XE hybrid was smoking and a dense smoke condition had formed. An explosion involving the burning of this dense smoke layer occurred while firefighters applied water to the vehicle. The explosion propelled the garage door 30 ft into the yard. No one was injured [26], though the garage door came into contact with the helmet of the incident commander as it traveled through the air. Figure 20 shows the condition of the garage after the explosion. Figure 21 shows the position of the garage door after the explosion.

Figure 20 – Responding firefighting crew [26].

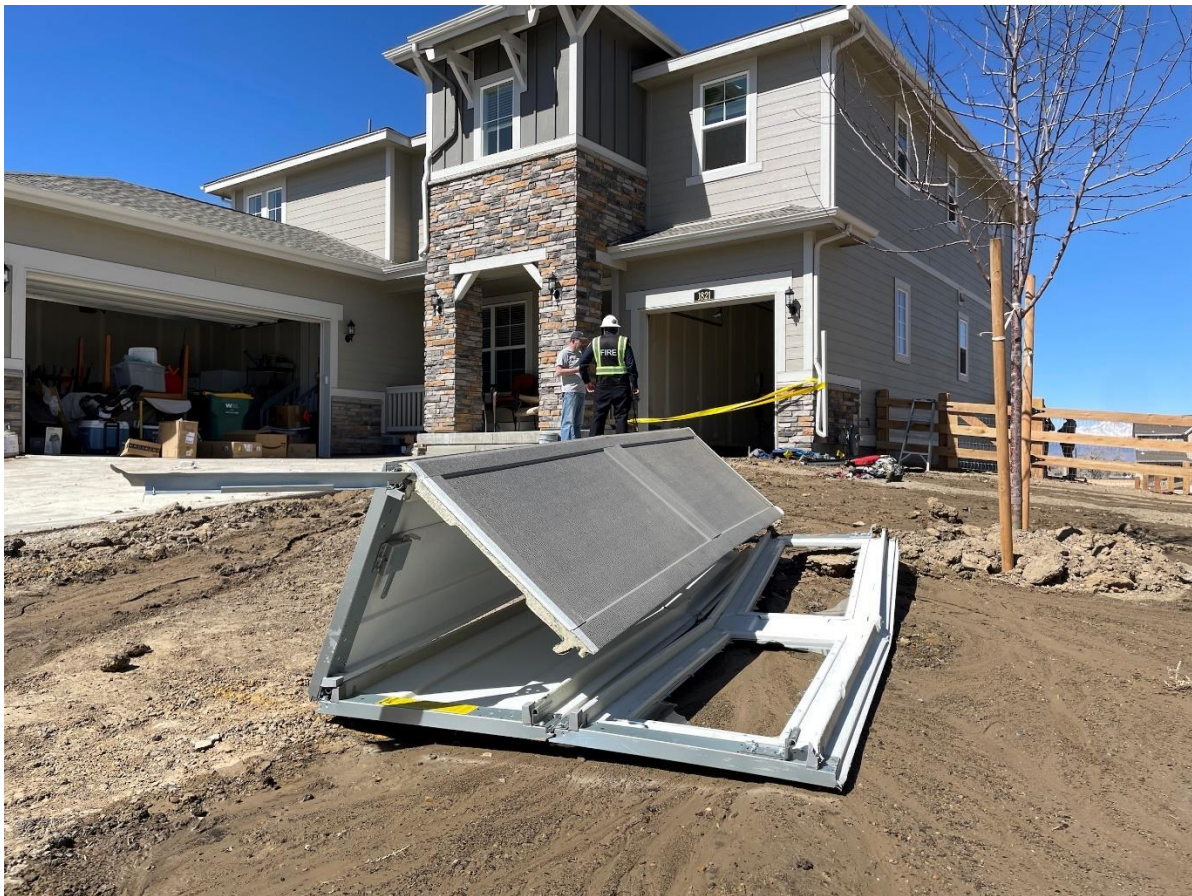
Figure 21 – Garage door location following garage explosion [26].

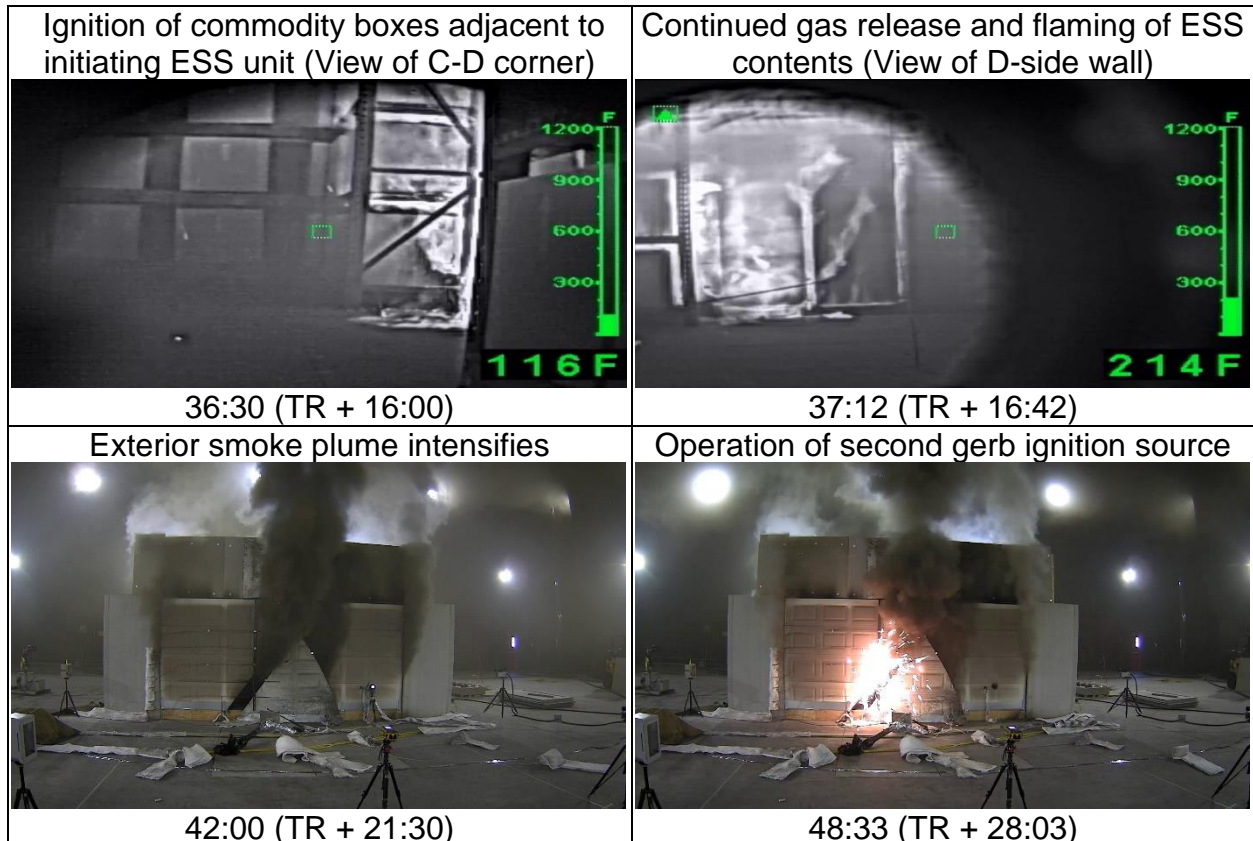
Figure 86 – Test events between 36 and 49 minutes of test time in Test 2.

The fire was allowed to burn until reaching a steady under-ventilated condition. This behavior was coupled with an increase in smoke production observed from the partially dislodged vent and garage door perimeter. Thermal runaway propagation continued in the center ESS unit (“Unit 2”). When it appeared likely that the batteries had reached a peak amount of thermal runaway propagation, fire department intervention was simulated with ventilation of the pre-cut opening.

The gerb did not cause immediate ignition of the vented smoke and gas plume. The increased ventilation from the opening, however, did result in fire growth and flaming out of the vent less than one minute after ventilation, as shown in Figure 86 and Figure 87. After approximately one minute of fire growth, the test was terminated by remotely opening the B-side and C-side doors, and initiating remote suppression.

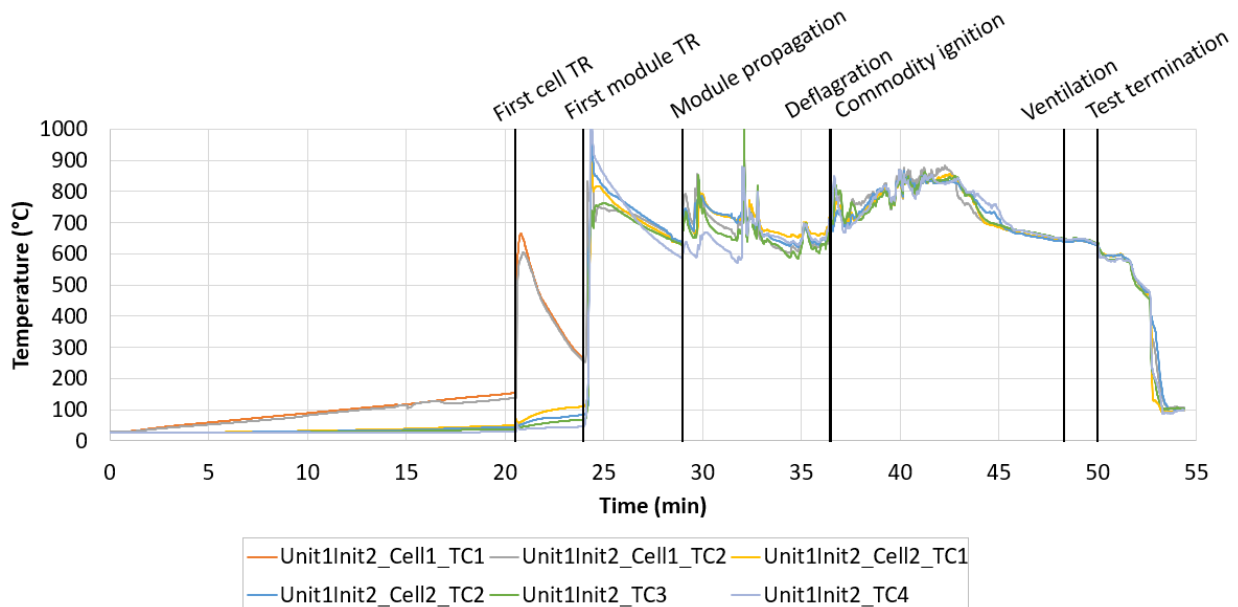
Figure 88 – Temperature measurements in the initiating battery module (“Unit1Init2”)

Test 2 was initiated by heating one cell (“Unit1Init2_Cell1”) at 6°C/min for 20 minutes and 30 seconds, at which time thermal runaway occurred. Surface temperature on the cell measured 155 °C at the onset of thermal runaway. Heater operation was discontinued at this time. Thermal runaway propagation through the rest of the cells in this module (“Unit1Init2”) occurred 3 minutes and 27 seconds later, as shown in Figure 88.

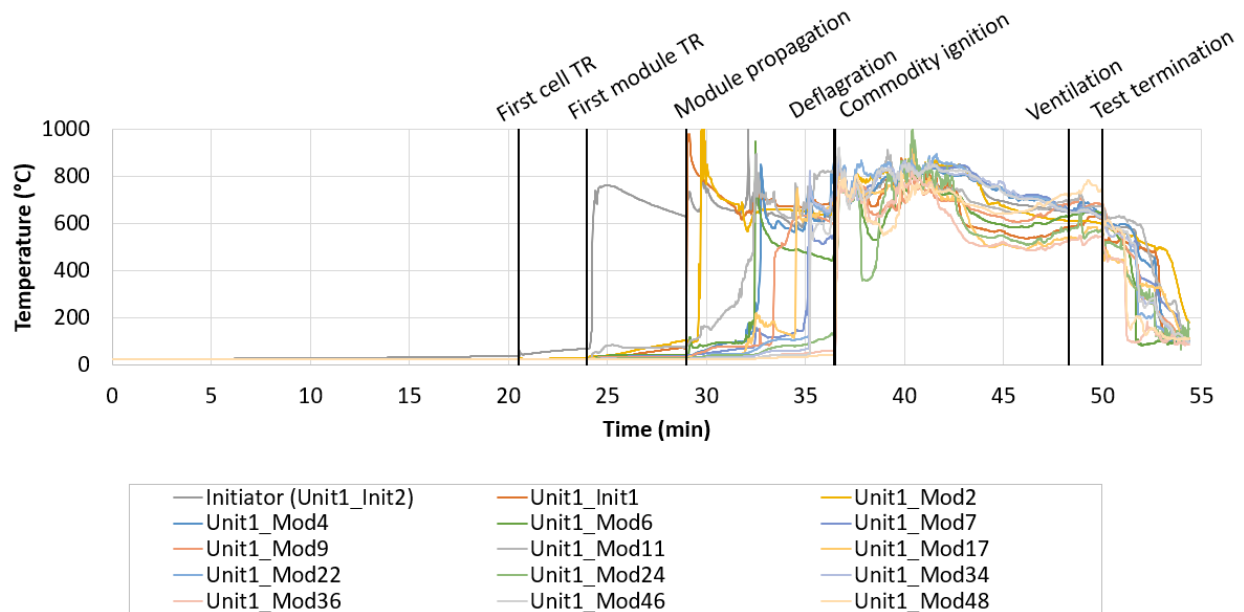
Figure 89 – Temperature measurements within the initiating unit (Unit 1) of Test 2.

runaway. Though all modules were not individually instrumented, it is estimated that 70% of the unit had experienced thermal runaway at the time of the deflagration, as shown through the temperature measurements of Figure 89 and visualization in Figure 90. Thermal imaging of the Unit 1 combined with temperature data suggest that complete propagation was observed in Module 1 through 21, with propagation through 50% of the modules between Module 22 and 48. Thermal images of Unit 1 leading up to the deflagration are included in Figure 91.

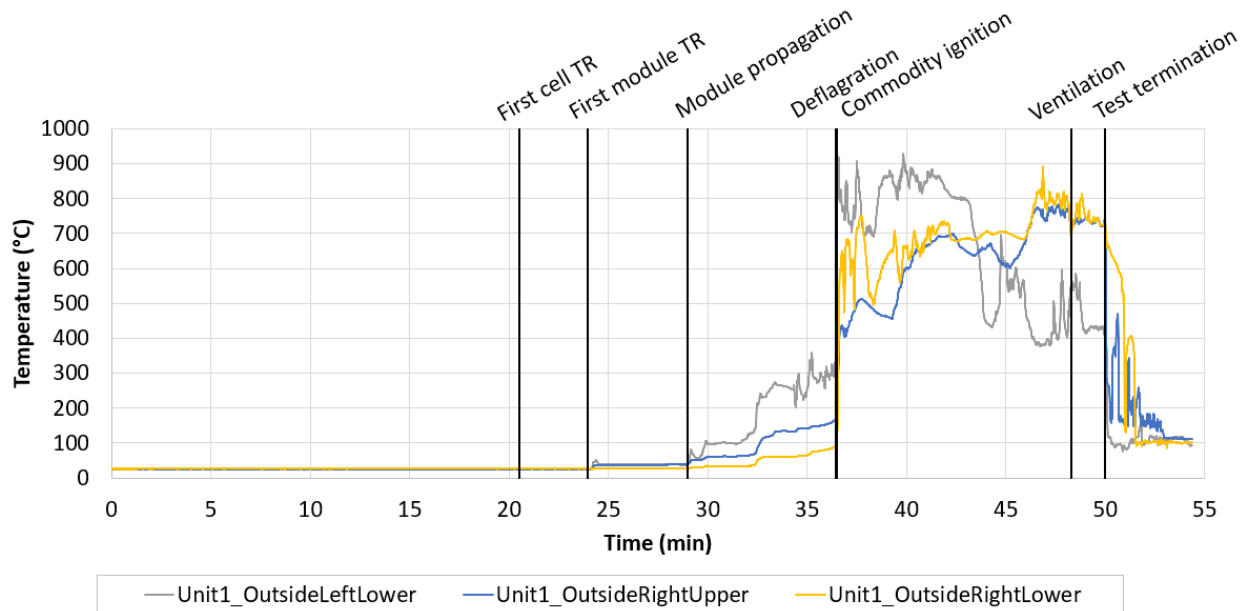
Figure 92 – Unit 1 enclosure exterior temperatures in Test 2.

Within 10 seconds of the deflagration, thermal runaway was observed in the remaining three instrumented modules of Unit 1. Temperatures measured on the exterior of the Unit 1 enclosure increased during the period between the first module-to-module propagation and the deflagration, reaching a maximum measured temperature of approximately 350 °C. Following the deflagration and subsequent commodity box ignition, unit enclosure temperatures rose rapidly to as high as 900 °C, as shown in Figure 92.

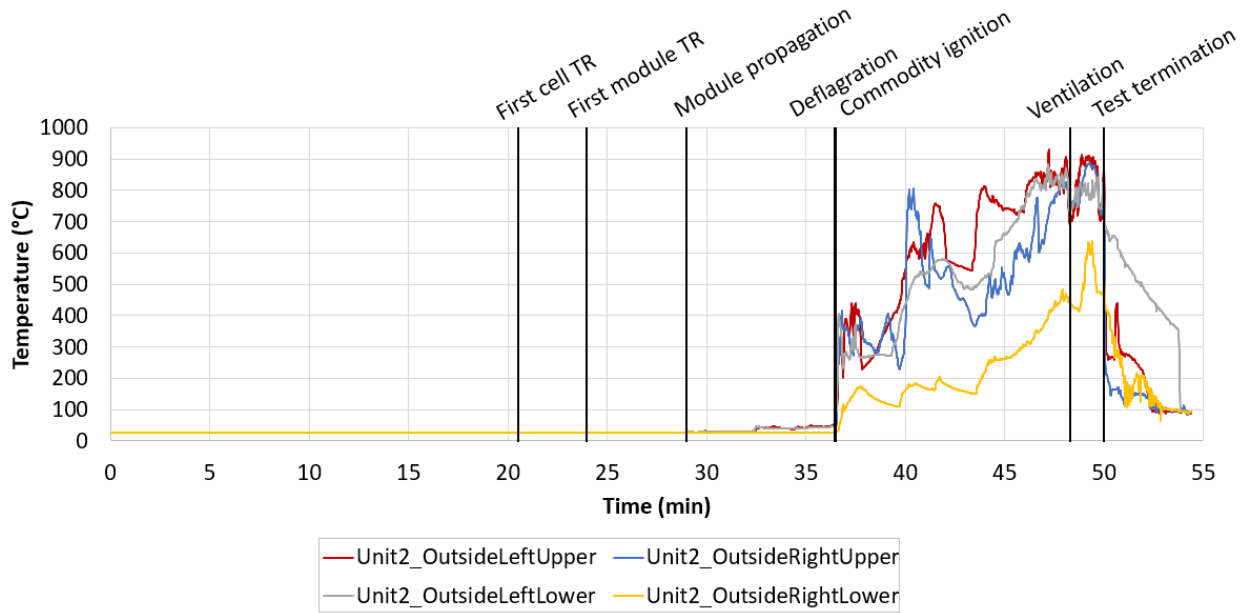
Figure 93 – Unit 2 enclosure exterior temperatures in Test 2.

Exterior enclosure temperatures measured on the center unit, Unit 2, did not increase above 50 °C prior to the deflagration and subsequent commodity box ignition, as pictured in Figure 93. Following the deflagration, upper exterior enclosure temperatures on Unit 2 climbed rapidly to approximately 400 °C. Another sharp increase is observed around 40 minutes which aligns with module temperatures indicative of thermal runaway within Unit 2, as shown in Figure 94. Interior module temperatures of Unit 2 shown in Figure 94 also indicate a high amount of thermal activity directly following the deflagration. Thermal runaway propagation in Unit 2 is identified by temperature and could not be verified by thermal imaging due to high smoke obscuration in the test structure.

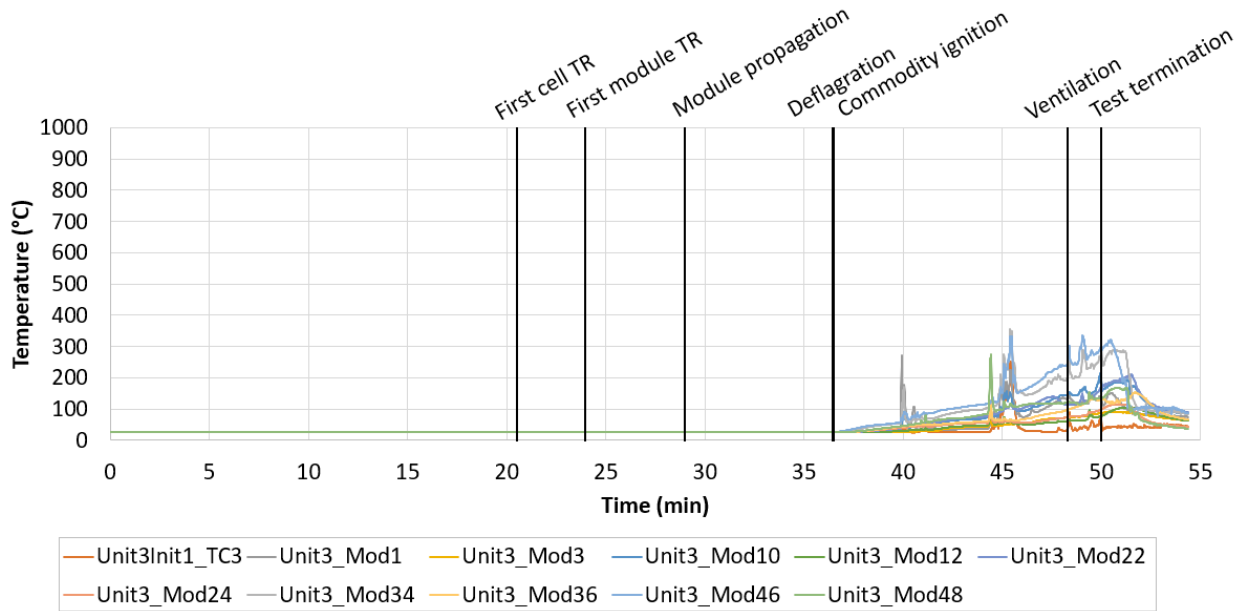
Figure 96 – Temperature measurements within the rightmost unit (Unit 3) of Test 2.

Exterior enclosure temperatures on the rightmost unit, Unit 3, did not show any temperature increase above ambient until the deflagration and subsequent commodity box ignition. For the period between the commodity ignition and test termination, temperatures measured on the outside of Unit 3 increased steadily to 500 °C, as plotted in Figure 95. Temperatures measured on the modules within Unit 3 increased in similarly steady fashion to a maximum of approximately 300 °C with no definitive confirmation of thermal runaway of any cells within the unit, as shown in Figure 96.

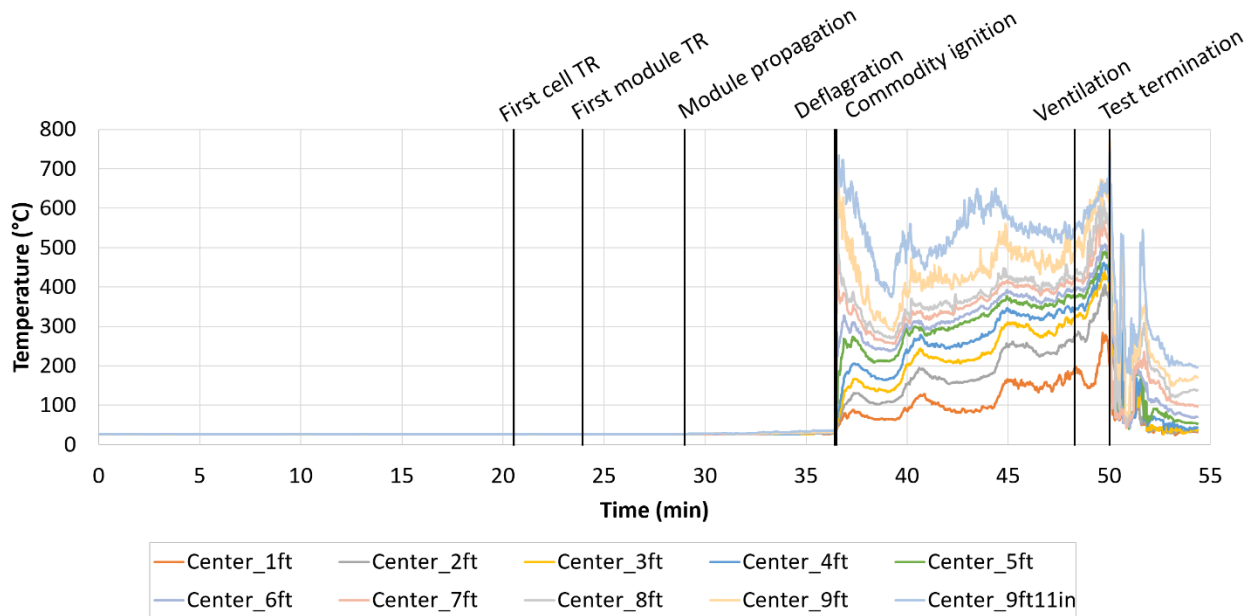
Figure 97 – Temperature inside the garage for Test 2.

Temperatures measured at the center of the garage did not increase from the first cell and module thermal runaway, as plotted in Figure 97. Following module-to-module propagation at 29 minutes, temperature began to increase to a maximum of 36 °C at the ceiling just prior to the deflagration due to the accumulation of effluent gases from thermal runaway, as pictured in the zoomed-in window of Figure 98.

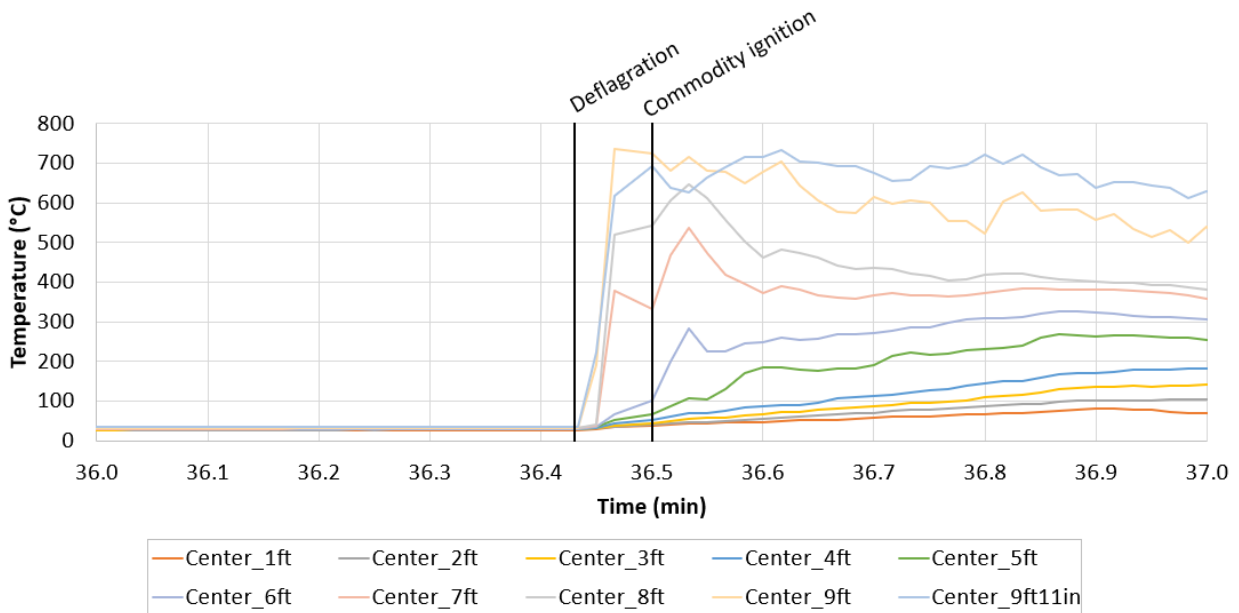
Figure 99 – Temperature inside the garage between 36 and 37 minutes for Test 2.

The deflagration and subsequent fire growth resulted in near instantaneous temperature rise spanning 100 °C at 1 ft off the floor to 700 °C at the ceiling, as shown in Figure 99. Temperatures remained in this range, increasing steadily with increasing burning in the garage. Temperatures increased faster following full operation of the pre-cut opening due to the increased ventilation of the fire. After test termination at 50 minutes, temperatures decreased to ambient as the fire was suppressed.

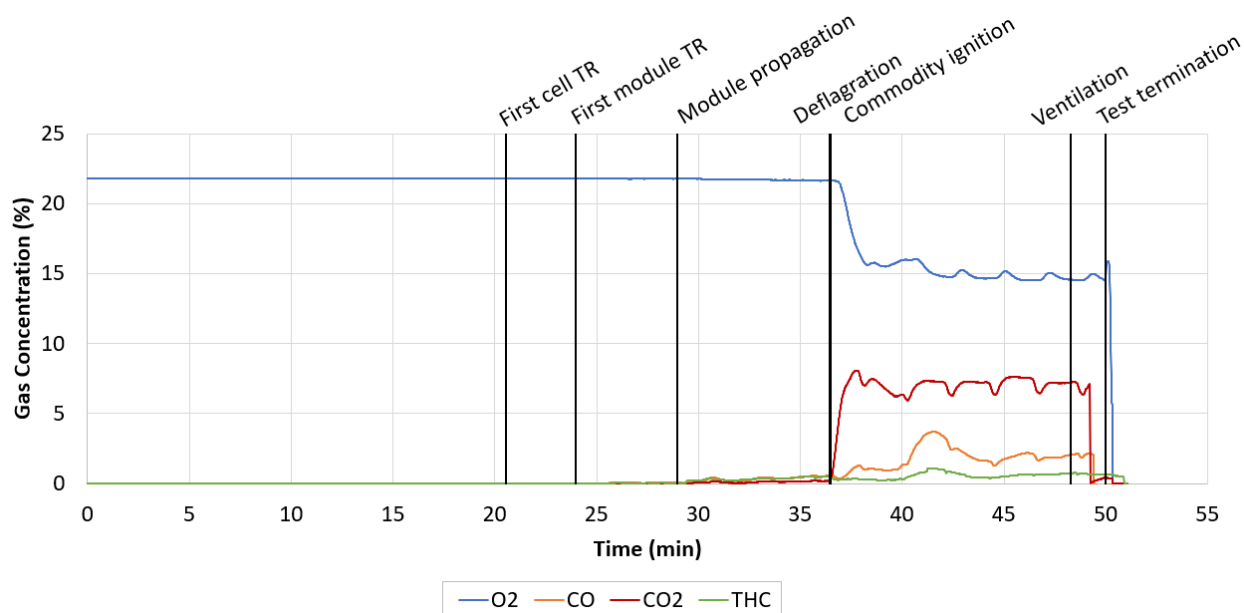
Figure 100 – Interior upper layer gas measurements for Test 2.

Battery vent gases were first measured following thermal runaway propagation through the first module (thirty 18650 component cells). Carbon dioxide measured 0.03 v%, CO measured 0.09 v%, and THC measured 0.05 v%. Following the beginning of module-to-module propagation and before the deflagration, the battery thermal runaway gases increased in concentration to 0.2 v%, 0.6 v%, and 0.6 v% for CO₂, CO, and THC, respectively.

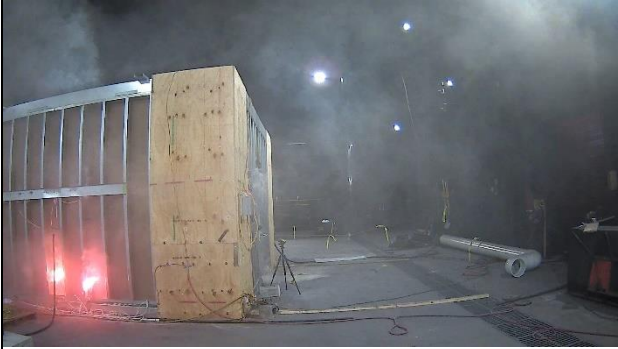
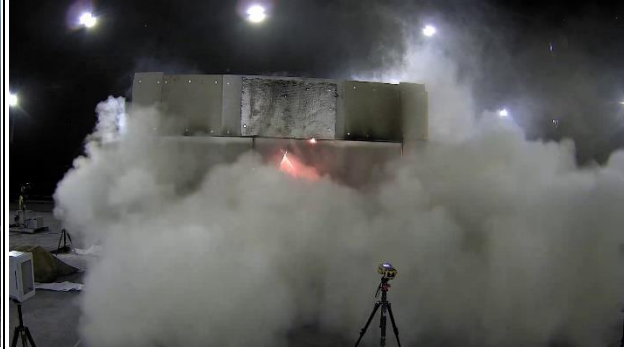
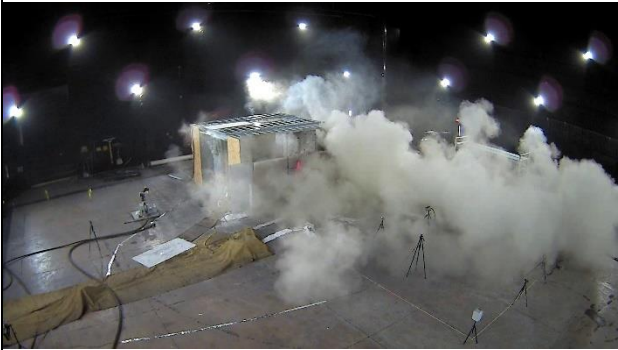
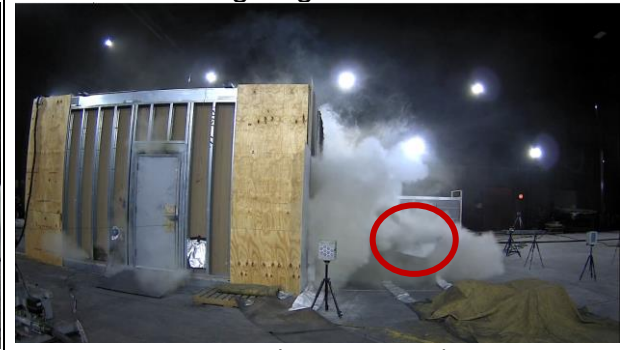
Figure 102 – Exterior effects of deflagration in Test 2.

Pressure generated by the deflagration was sufficient to partially dislodge the pre-cut opening from the garage door and eject a stream of smoke and battery gas across a 60-70 ft span of the laboratory. Flames were observed at the garage door opening as well as from conduit openings through the D-side wall of the structure, as shown in Figure 102. The pressure wave was sufficient to push the ceramic wool insulation protecting some instrumentation in the driveway approximately 5 ft away.

Flaming visible from conduit openings on D-side wall	Flaming from ventilation cut in garage door

36:26 (TR + 15:56)	36:27 (TR + 15:57)
Smoke plume pushed 60-70 ft from structure	Ceramic fiber insulation thrown from near garage door

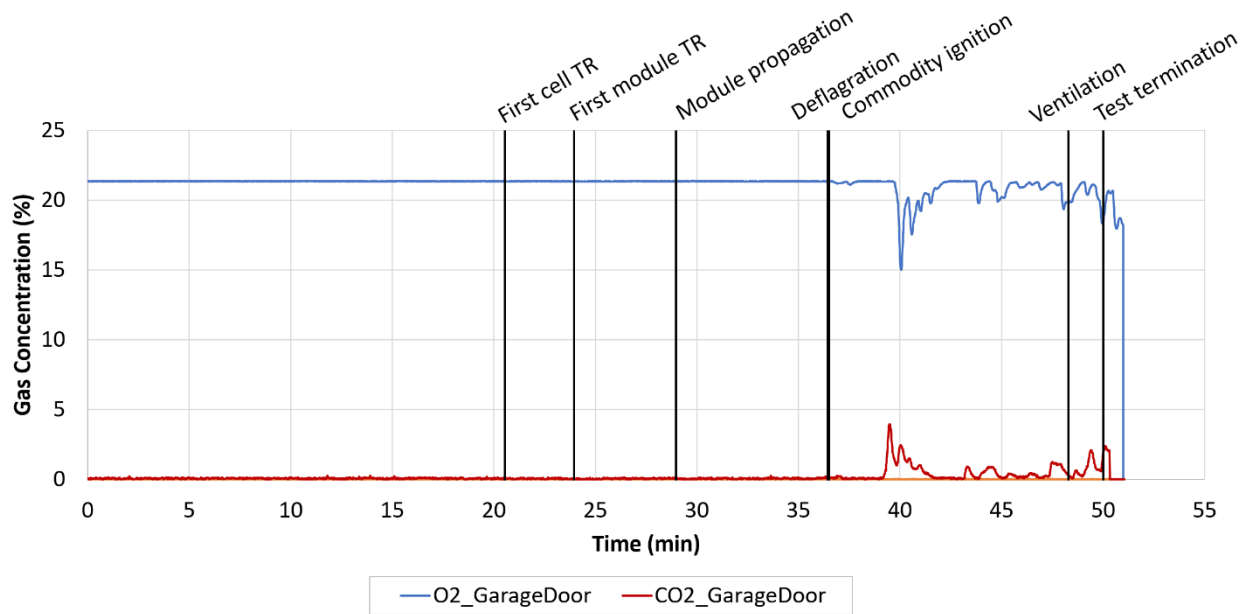
Figure 103 – Exterior gas measurements at the garage door in Test 2.

At the probe outside the garage door, CO₂ and O₂ did not deviate from baseline measurements during initial thermal runaway propagation or immediately following ignition and the resulting deflagration. The CO sensor malfunctioned during Test 2, so CO concentration is not reported. Following fire growth and additional thermal runaways around 39 minutes, O₂ in this location dropped to 15 v% and CO₂ increased to a peak of 4 v%. Concentrations in this location returned to ambient with deviations less than 1 v% as the sampling location was intermittently in and out of the gas plume.

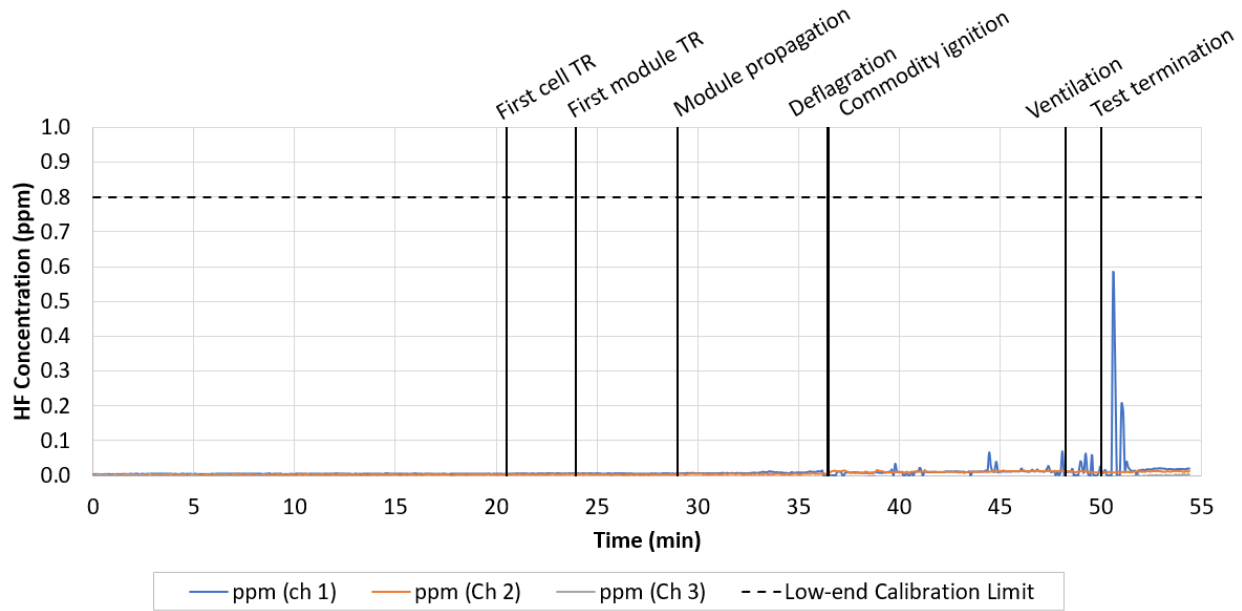
Figure 104 – HF measurements in Test 2.

HF gas was not measured above the low-end calibration limit (0.8 ppm) in Test 2.

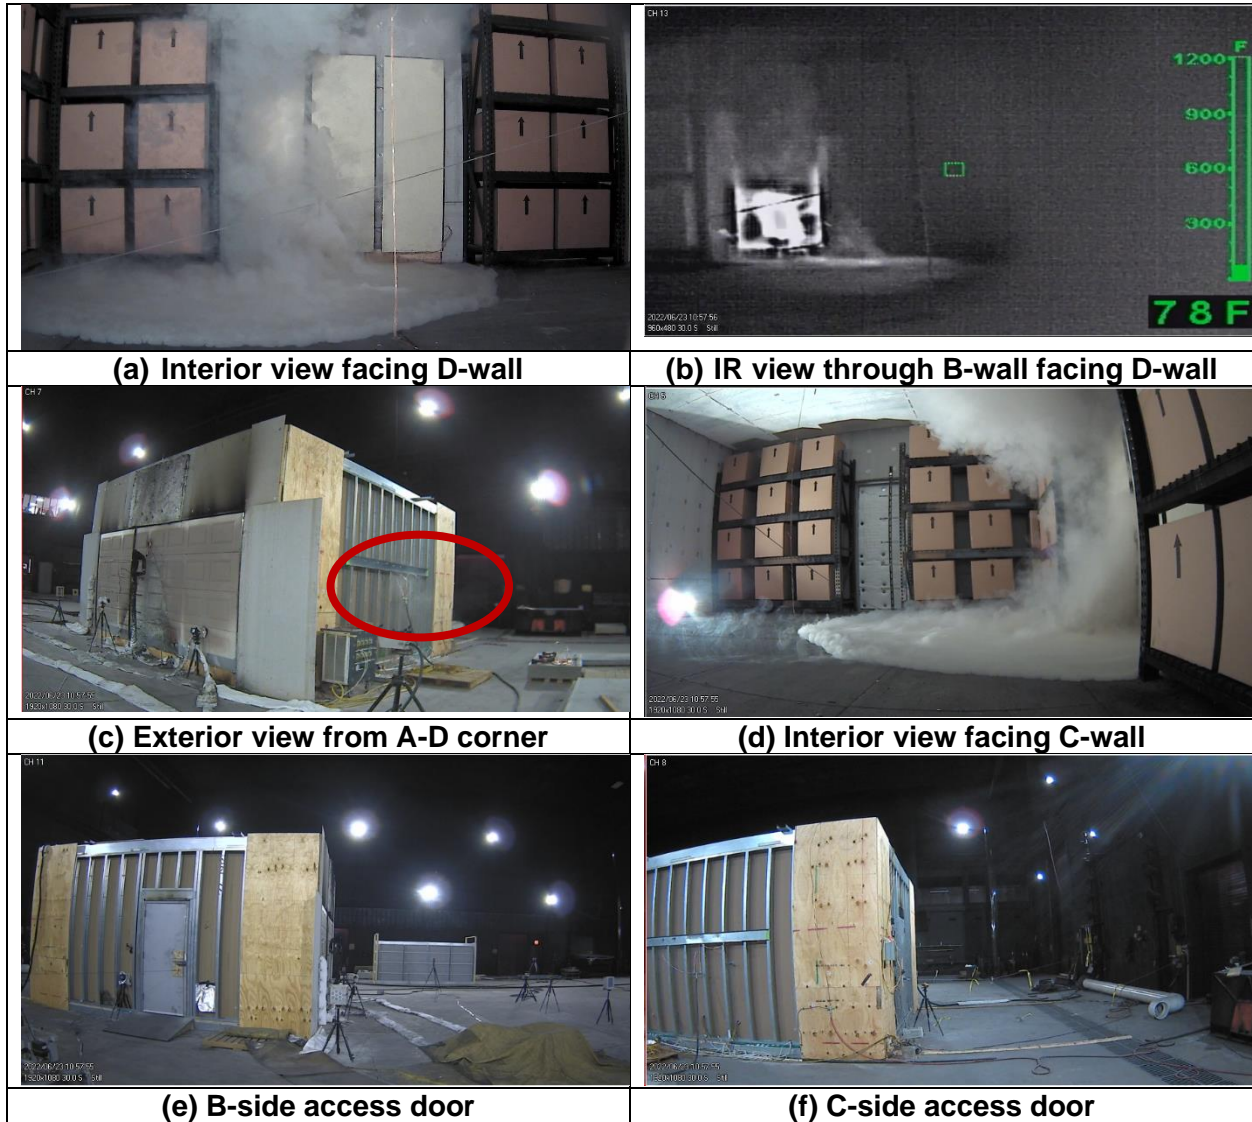
Figure 105 – Gas accumulation from battery thermal runaway (24:45, TR + 4:45).

Figure 105 compares the interior and exterior views of the ESS in a period of active thermal runaway propagation. A cloud of flammable battery gas emanated from Unit 1. Distinctive, low laying vapor clouds provided a clear indication of battery involvement from the interior cameras. Interior IR views show both the low laying cloud and the heat signature of battery thermal runaway in Unit 1. By contrast, exterior visuals do not provide any indication of battery thermal runaway. Smoke and gas are only visible at one location near a penetration used for mounting the ESS, which is unlikely to exist in a typical installation. There is no visual indication of thermal runaway, smoke, or fire near either B-side or C-side access door.

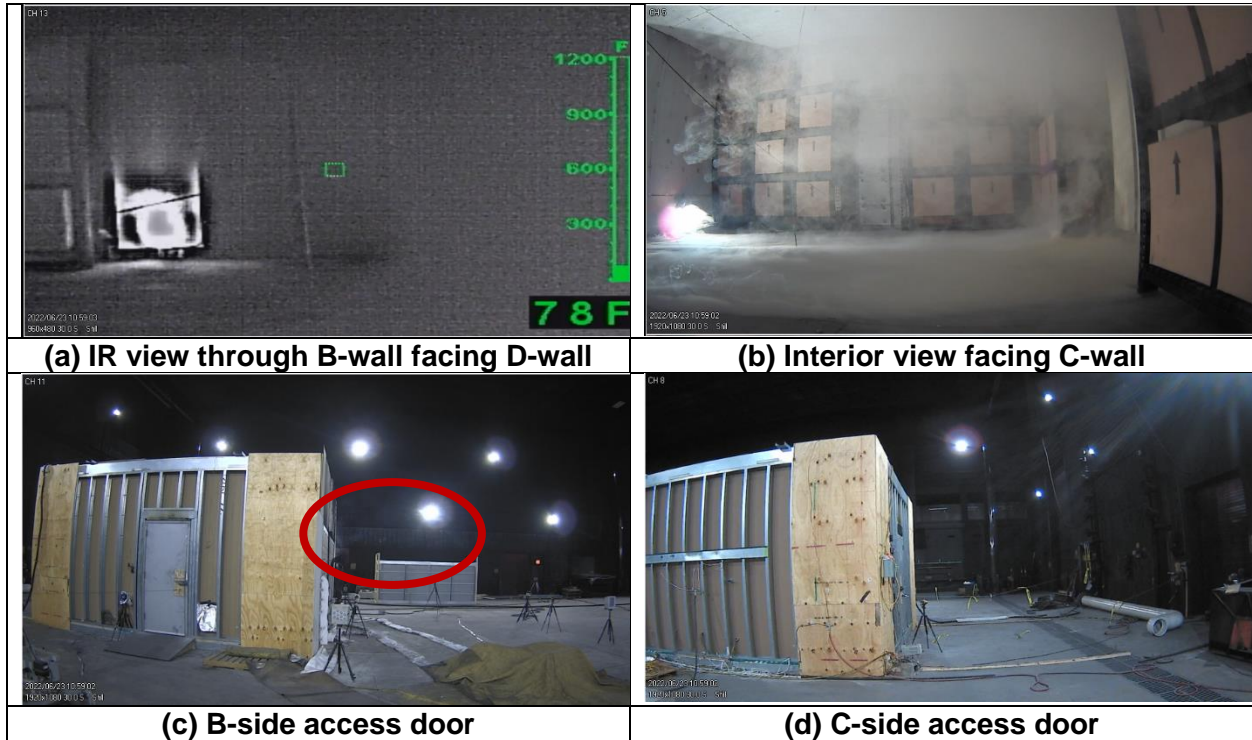
Figure 106 – Early exterior smoke showing (25:50, TR + 5:20).

Figure 106 captures views around the structure one minute after the images of Figure 105. Interior HD and IR camera views reliably indicate thermal runaway. Smoke and gases are not visible around the perimeter of either B-side or C-side access door. This time aligns with the first exterior view of smoke and gas coming from the edges of the garage door.

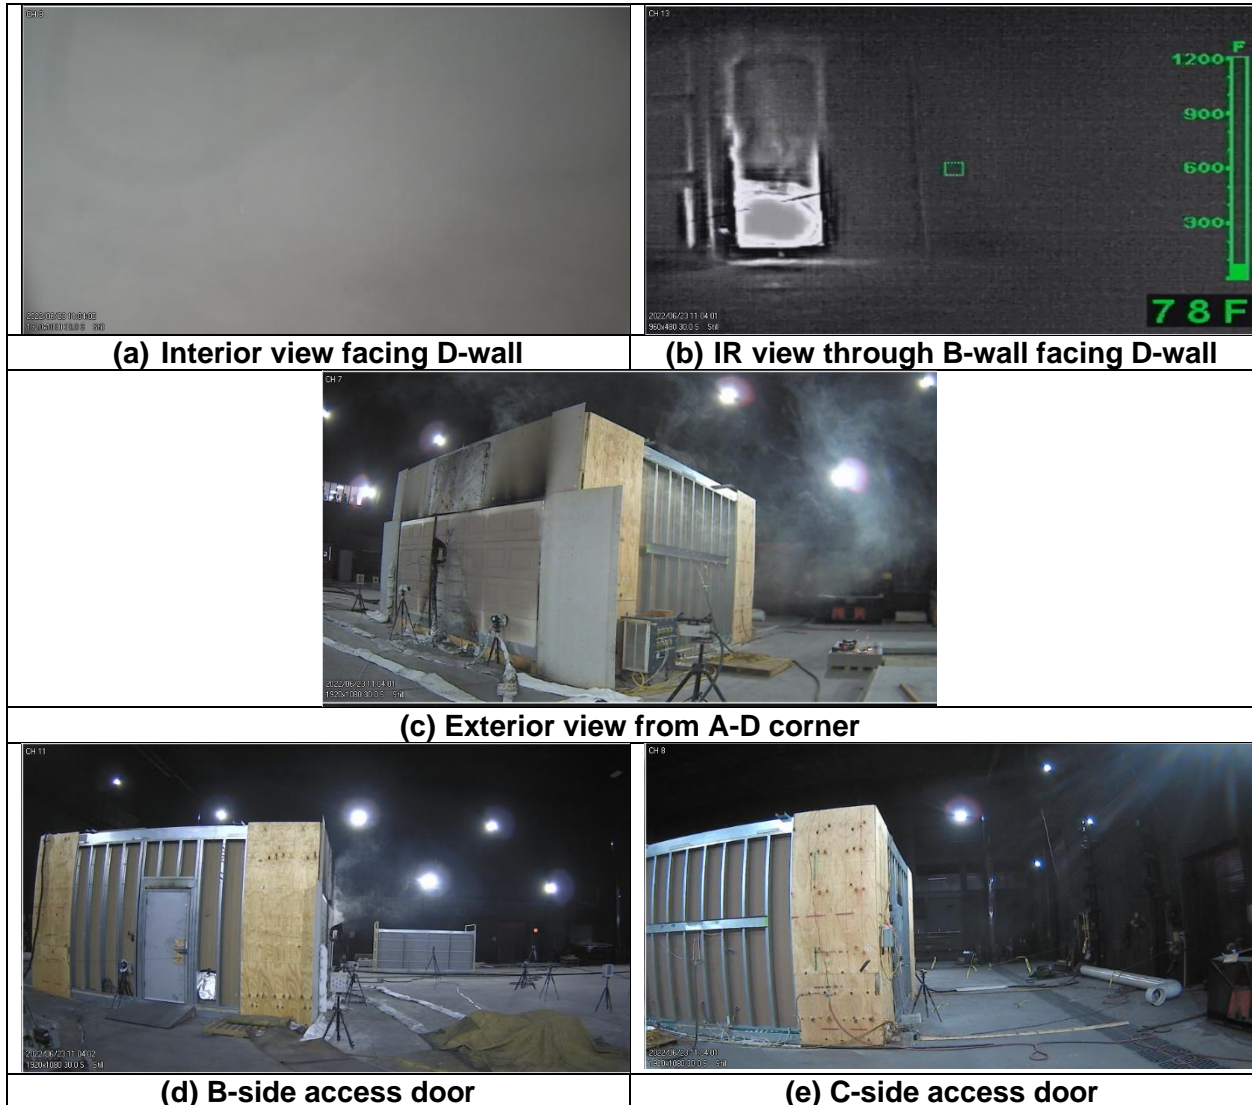
Figure 107 – Exterior view during propagating thermal runaway (30:50, TR + 10:20).

Figure 107 is assembled of images taken 5 minutes after Figure 106. Module-to-module thermal runaway propagation continues through Unit 1. At this point, interior camera views are obscured by the accumulation of battery gas inside the garage. IR imaging, by contrast, is able to see through this environment and identify heat signatures from Unit 1 which indicate ongoing thermal runaway behavior. At this point in the process of thermal runaway propagation, battery gas is visible consistently outside the garage. Unlike the low-laying vapor clouds of the interior in Figure 105 and Figure 106, battery gas outside the garage is dispersed and mildly buoyant. No gases were visible around the perimeter of the B-side or C-side access door.
