FIRE RESEARCH AND DEVELOPMENT TECHNICAL REPORT

Considerations for Fire Service Response to Residential Battery Energy Storage System Incidents

December 4, 2023

Prepared for the International Association of Fire Fighters

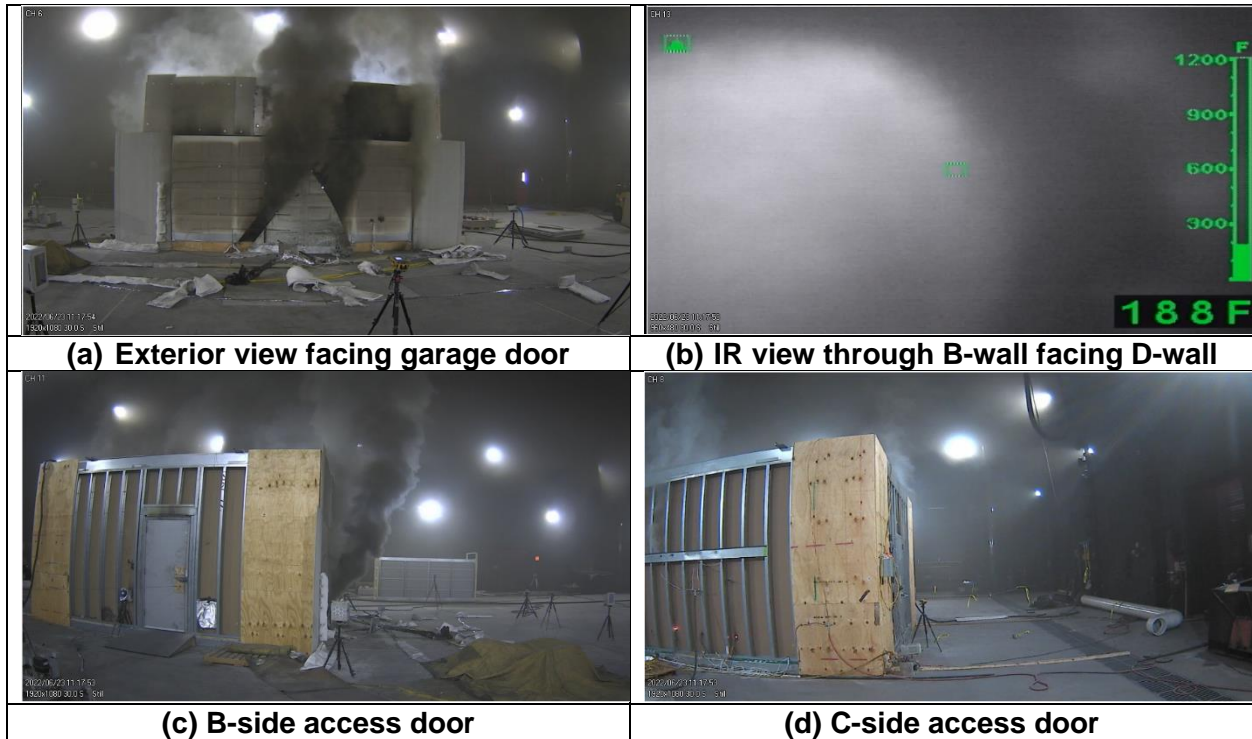
Figure 112 – View during suspected thermal runaway propagation (44:42, TR + 24:12).

Figure 112 shows exterior conditions 3 minutes after the conditions of Figure 111, during a time when thermal runaway propagation was suspected based on temperature measurements inside Unit 2. Visual assessment does not provide an indication of thermal runaway propagation. The buoyancy-driven smoke plume emitted from the gaps in and around the garage door is not visually distinct from the images of Figure 111. Smoke was observed from the upper edge of the B-side and C-side access doors. This smoke does not provide an indication of battery involvement. Interior IR views remain obscured and do not confirm thermal runaway propagation.

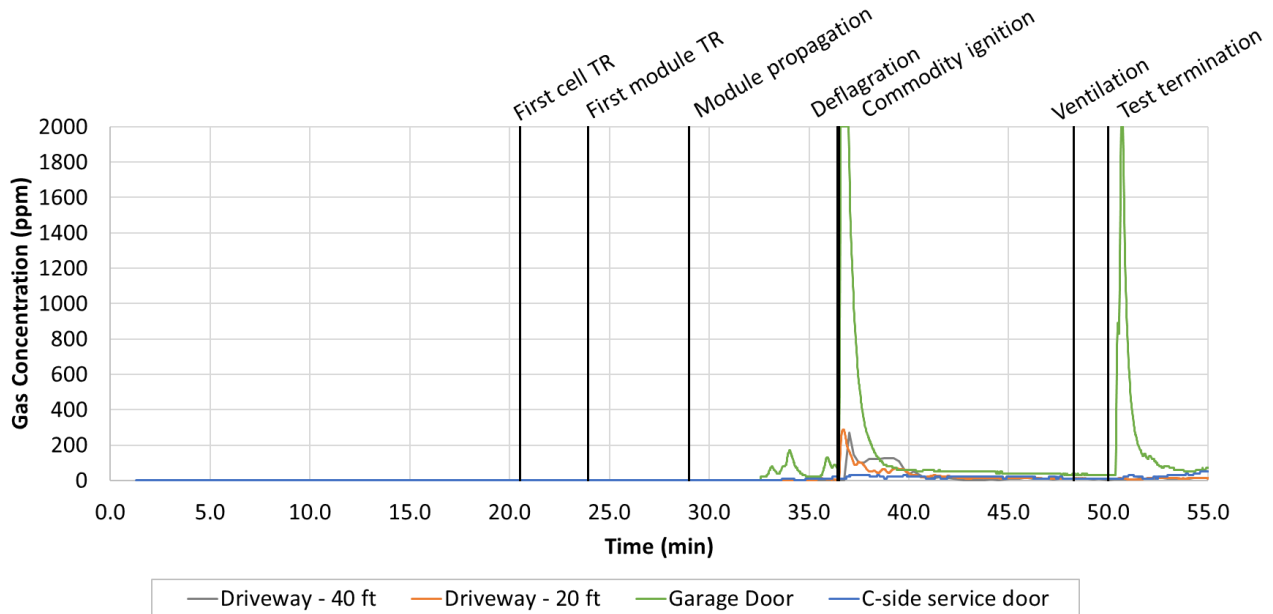
Figure 113 – All portable meter CO measurements in Test 2.

Figure 113 through Figure 118 provide gas measurement data from the meters for Test 2. Carbon monoxide measurements from the four meters, given in Figure 113, indicated that for approximately 4 minutes prior to the deflagration, up to 200 ppm of CO was measured near the garage door due to leakage of thermal runaway gases from the garage. Prior to the deflagration, CO was measured at the garage door (200 ppm) and C-side access door (20 ppm); CO was not measured at the other two driveway measurement locations. After the deflagration, CO measurement at the garage door meter – which was knocked to the ground as a result of the deflagration – peaked to saturation at 2000 ppm before returning to a baseline of approximately 50 ppm over 4 minutes. The meters in the driveway at 20 ft and 40 ft were physically undisturbed by the deflagration but measured peaks of 275 and 260 ppm, respectively, as the smoke from the deflagration dispersed into the lab, as shown in test video. The C-side service door meter registered a 20 ppm increase in CO following the deflagration.

At the point of test termination, a fog spray pattern of suppression water into the B-side access door pushed a smoke plume out of the garage door V-cut opening. Test video shows the plume engulfing the garage door meter laying on the ground just outside of the garage door. The metered once again peaked at a saturation measurement of 2000 ppm. The other meters in the driveway did not measure a reaction to test termination. The C-side service door meter registered a 10-20 ppm increase during test termination.

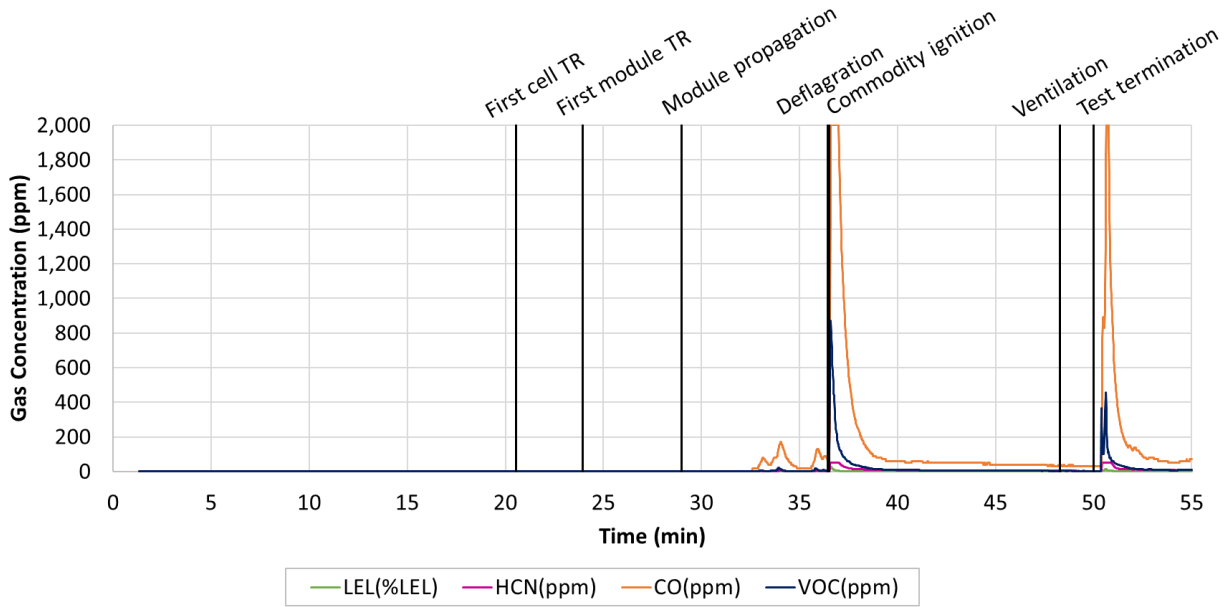
Figure 114 – Portable meter measurements at garage door in Test 2.

The garage door meter measured peaks of VOCs, LEL and HCN concurrently with the previously discussed peaks of CO, as shown in Figure 114 and Figure 115. LEL did not register above zero prior to the deflagration. Following the deflagration and test termination, the meter registered 870 ppm and 440 ppm of VOCs, respectively. The HCN measurement peaked at 50 ppm during both events. LEL peaked at 26% and 15%, respectively. It is assumed that the measurements made immediately after the deflagration measured the combination of combustion byproducts and non-combusted thermal runaway effluent gases in the ejected smoke. After test termination, the meter measured the products of combustion of the commodity boxes or thermal runaway effluent gases. In the case of HCN, cross sensitivities to CO may have influenced the measurement in both cases, or HCN may have been generated by the burning of the ABS plastic module cases.

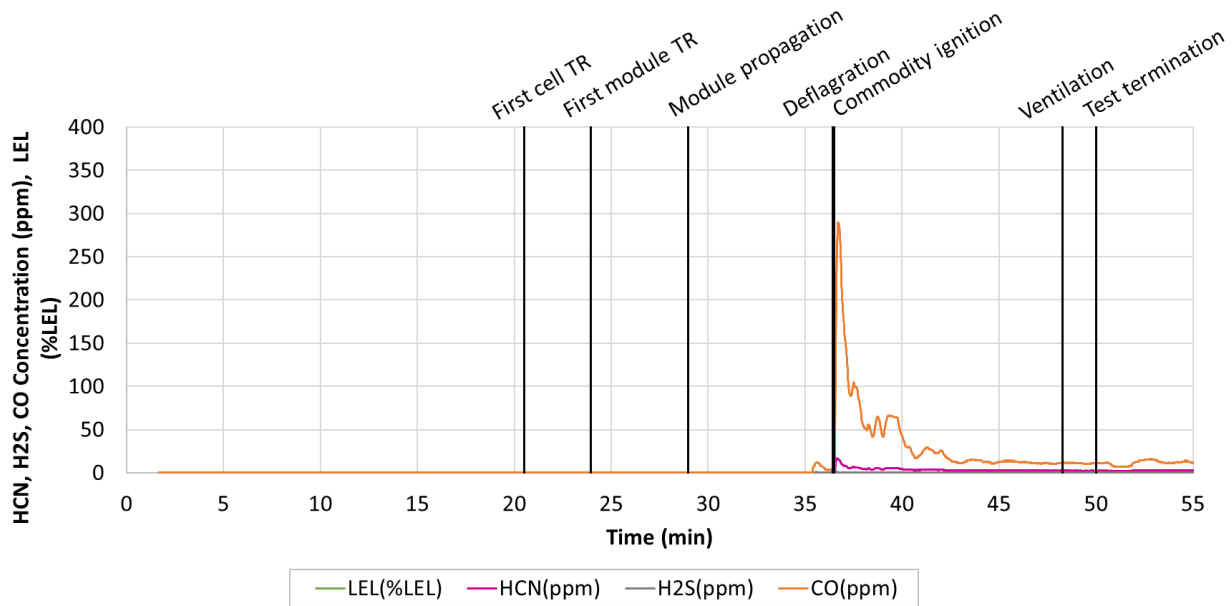
Figure 116 – Portable meter measurements at driveway 20 ft location in Test 2.

The meter at 20ft down the driveway did not register LEL, H₂S or HCN prior to the deflagration, as indicated in Figure 116. Only 17 ppm of CO registered prior to the deflagration. Immediately after the deflagration, the meter registered concurrent spikes of CO and HCN, at peaks of 285 ppm and 20 ppm respectively, due to the plume of combustion products being dispersed down the driveway. Following the simulated fire service intervention and ventilation, levels of CO up to 15 ppm were measured at the

meter location for the remainder of the test. LEL and H₂S were never measured above zero in this location for the duration of the test.

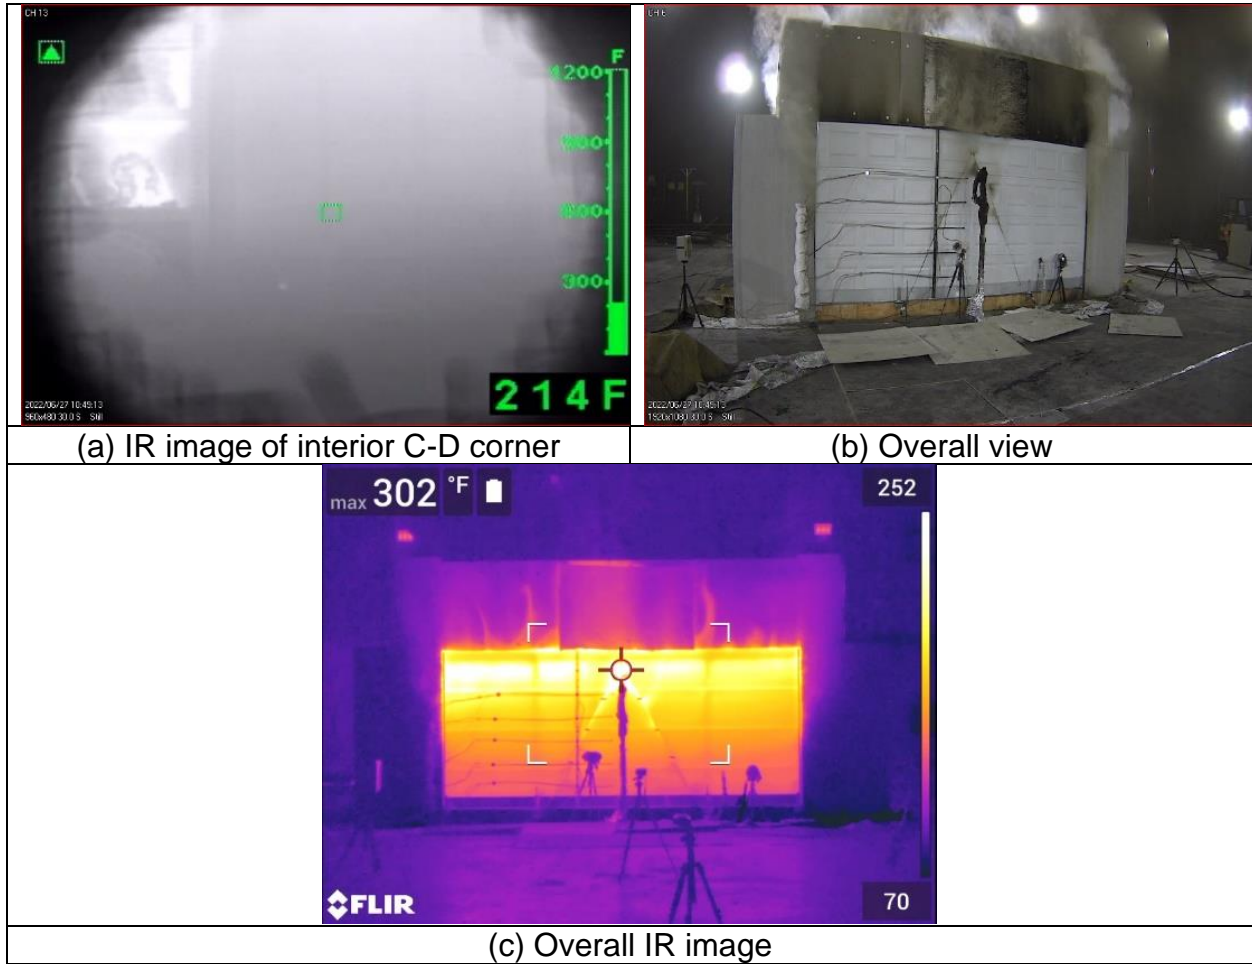
Figure 137 – Images from first module thermal runaway (32:11).

Images are taken from three times: 1) during the first 18650 cell thermal runaway (19:14), 2) during the first module thermal runaway (32:11), and 3) after at least 6 modules experienced thermal runaway within 90 seconds (43:56). The TIC image on the left side of Figure 138 shows a thermal signature at residential ESS Unit 1 after multiple modules have entered into thermal runaway. The venting gases are also visible, but more difficult to distinguish. It was not possible to distinguish the thermal signature of individual 18650 cells undergoing thermal runaway. However, it was possible to identify thermal runaway propagation once multiple module events had occurred and the heat had sufficiently transferred into the residential ESS enclosure walls.

Figure 136 – Figure 138 demonstrate that there were no thermal effects from the thermal runaways visible from the exterior of the garage during the ongoing thermal runaways.

Further, comparison of the images over time shows that the thermal conditions were governed by the generation of heat from the ventilation-limited Group A commodity fire and that the thermal energy contributed during thermal runaways and any potential burning of flammable battery gases did not alter the thermal picture as viewed in Figure 136 – Figure 138 in any discernable way.

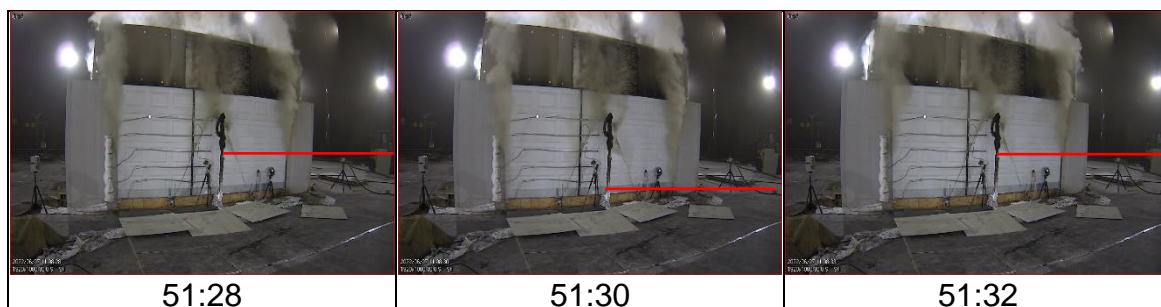
The clearest example of this phenomenon that occurred in Test 3 is demonstrated in Figure 139, which shows the smoke venting around the edges of the garage door – not only the vent kerf – at three times separated by two seconds each. In the first image, the neutral plane is seen at the approximate half-height of the door. The neutral plane is indicated in this case by the height above the floor where smoke is escaping from the garage door edges. Two seconds later, in the middle image, during a probable thermal runaway³, the neutral plane descended to the floor. Another two seconds later, the neutral plane returned to the half-height of the door. A red line has been superimposed over the neutral plane to aid in identifying the neutral plane height. This phenomenon was not seen in Test 1 and is atypical of ventilation-limited fires.

Figure 139 – Short lived transient pressure increase affecting neutral plane height.

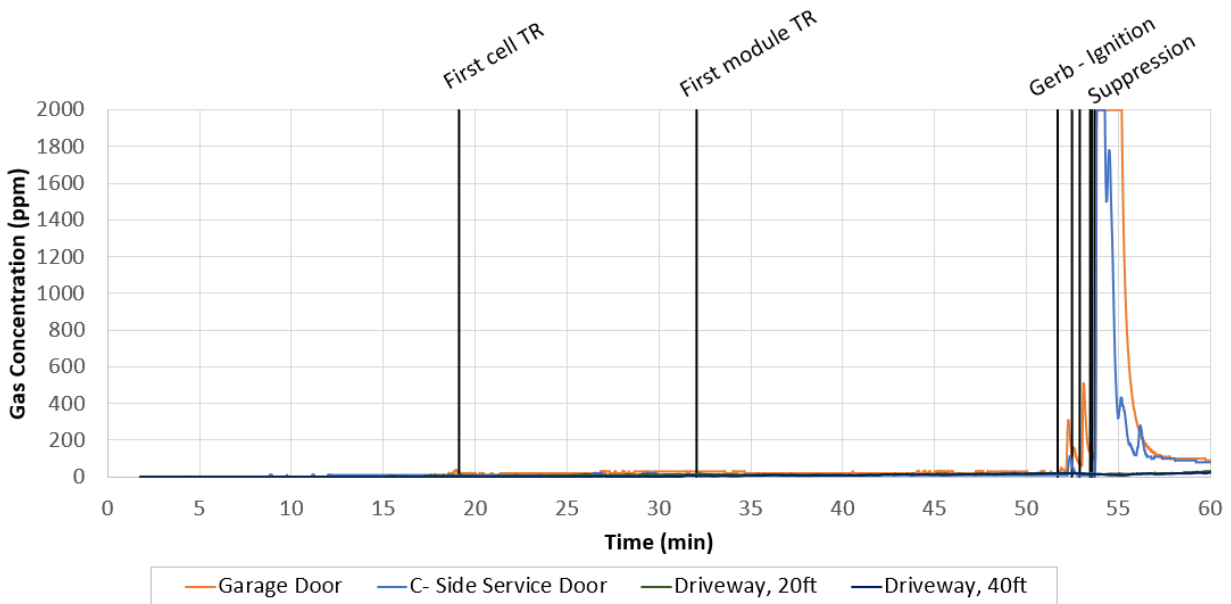
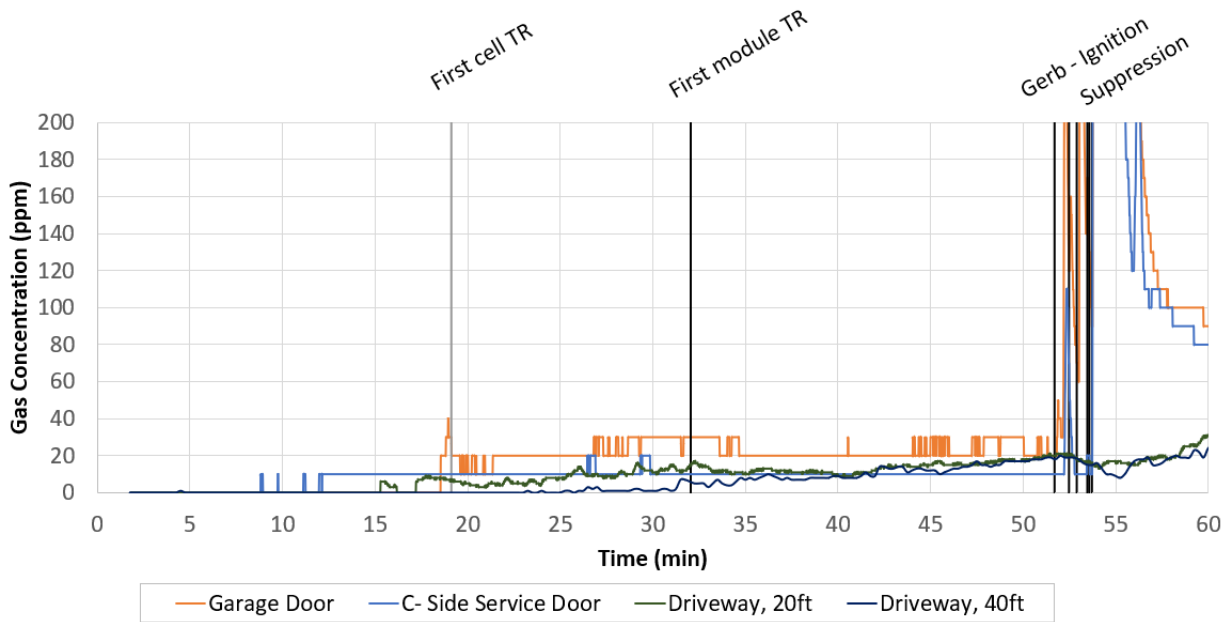
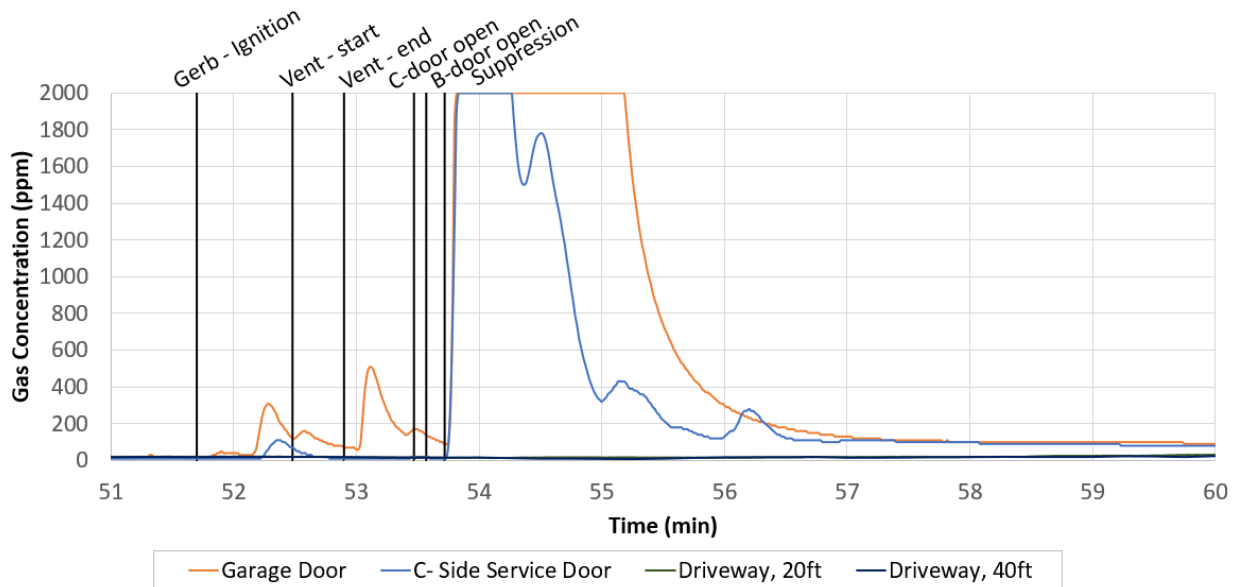
Figure 140 – Figure 142 plot the CO measurements from all four meters during Test 3. During the first 52 minutes of Test 3, during which time the commodity boxes were involved in flaming and only the first ESS module had experienced thermal runaway, a maximum CO level of 30 ppm was measured on any meter. This concentration was measured at the garage door. During this same period and until the end of the test, the two meters located in the driveway displayed a steady increase in CO measurements from zero to approximately 25 ppm as products of combustion from the test diffused into the lab.

Near 52 minutes and 20 seconds, within one minute of gerb activation, the garage door meter and C-side service door meter measured CO concentration peaks of 300 ppm and 100 ppm, respectively. Test video indicates increased visible gas leakage from the compartment during this time. It is possible that gas ignitions by the gerb caused minor overpressures which increased gas leakage from the compartment. A similar peak in CO was measured at the garage door near 53 minutes and 15 seconds. This second peak at the garage door was caused by pulsations in the fire plume emanating from the garage door inverted V-cut vent after it was opened.

At the time of suppression, with both service doors and the garage door vent opened, plumes of gas are pushed out of these openings by the suppression fog stream. These plumes visually envelope the C-side door meter and garage door meter causing saturation measurements (2000 ppm) on both meters.

Figure 140 – All portable meter CO measurements in Test 3 (0-2000 ppm).

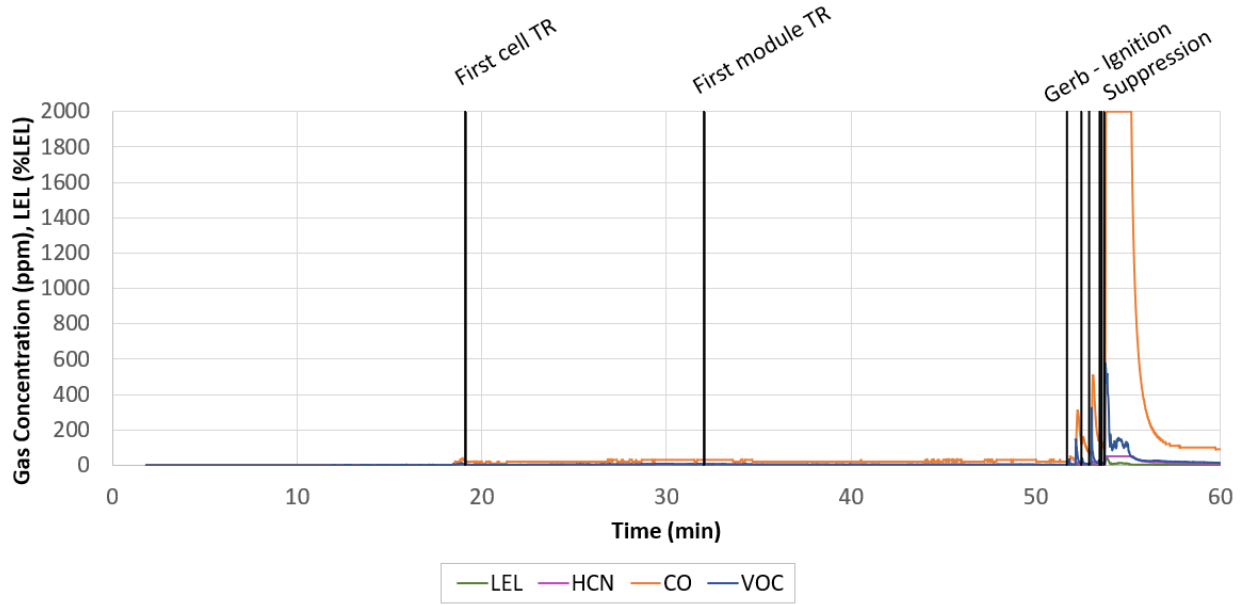
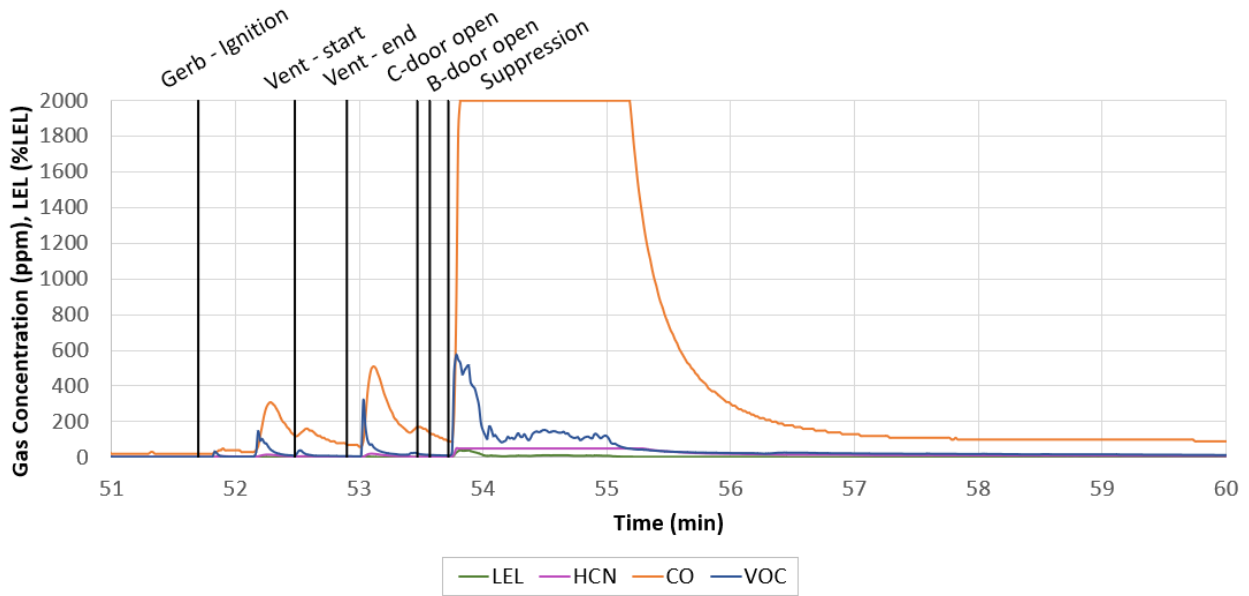
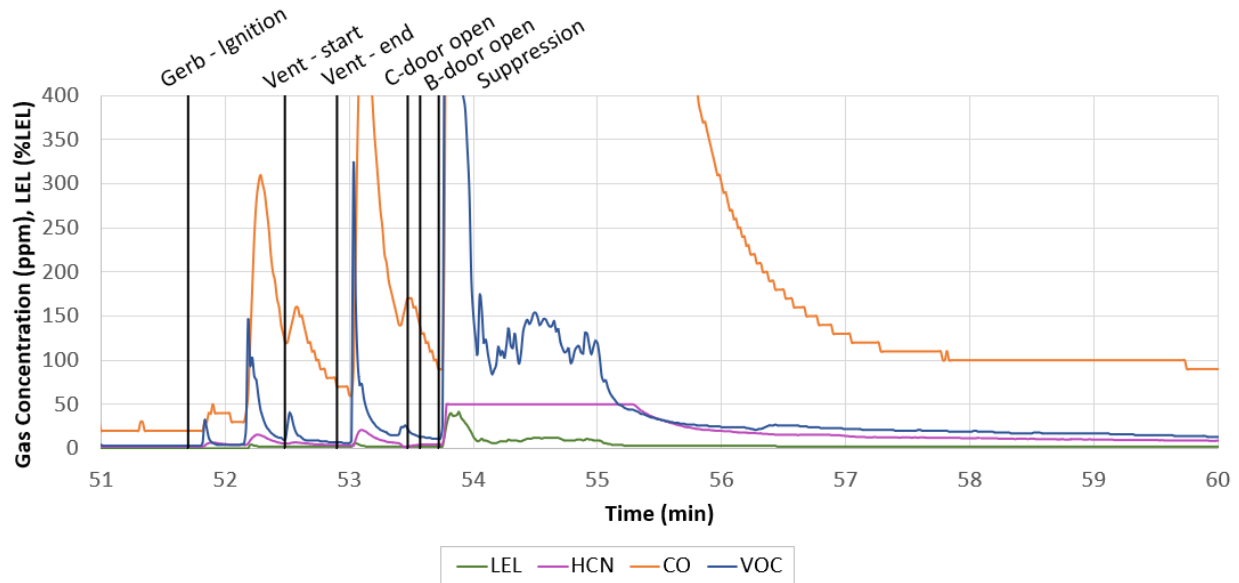
The peaks of CO measured in the garage door meter were accompanied by lesser peaks of HCN, VOCs and LEL (Figure 143 –Figure 145). Before the ventilation sequence, peak measurements were 30 ppm CO, 2 ppm HCN, 8 ppm VOC, and 0 % LEL. Between the beginning of the ventilation sequence and the initiation of suppression, peak measurements were 500 ppm CO, 20 ppm HCN, 320 ppm VOC, and 5 % LEL. During suppression, CO saturated at 2000 ppm, HCN saturated at 50 ppm, VOC peaked at 600 ppm, and LEL readings measured up to 45% LEL.

Figure 143 – Garage door meter measurements during Test 3.

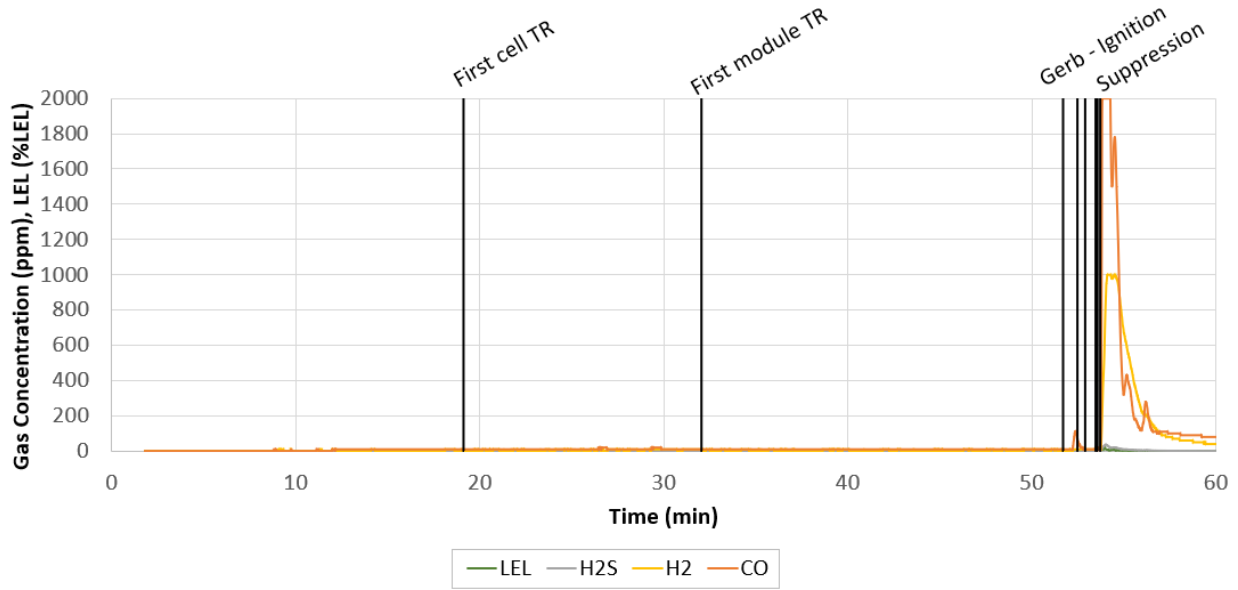
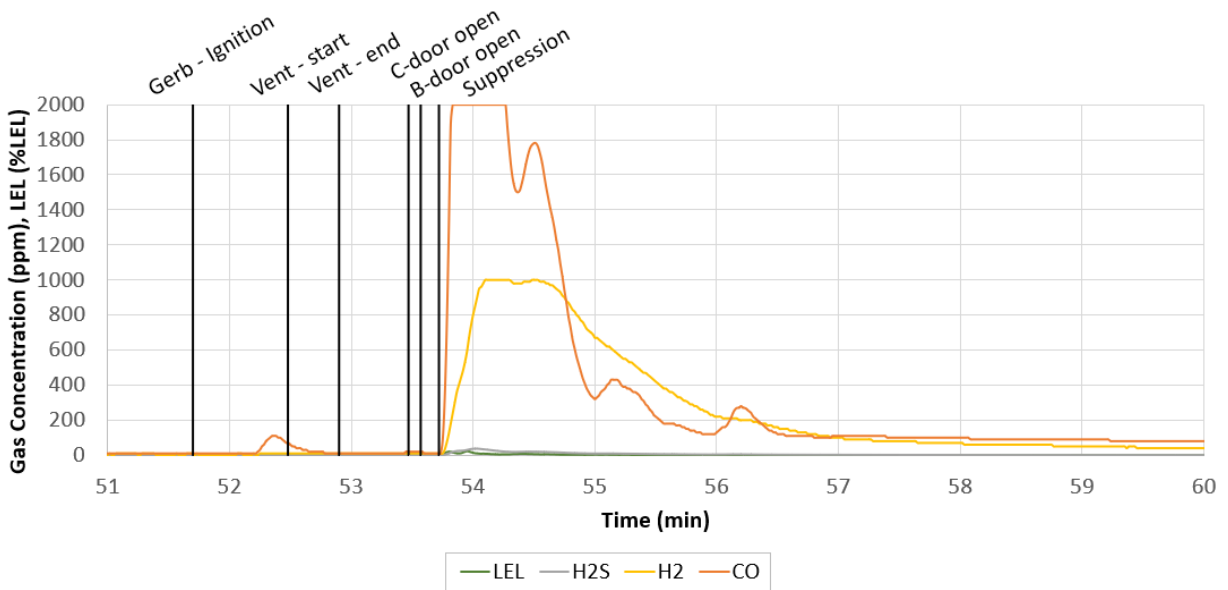
Similarly, the peaks of CO measured in the C-side door meter were accompanied by lesser peaks of hydrogen and LEL (Figure 146 and Figure 147). Peak concentrations before the ventilation sequence were 20 ppm CO, 10 ppm H₂, 0 ppm H₂S, and 0 % LEL. No peaks other than CO (110 ppm) were observed during the increased gas leakage that occurred in the window between the first gerb ignition and suppression. During suppression, CO saturated at 2000 ppm, H₂ saturated at 1000 ppm, H₂S peaked at 35 ppm, and LEL peaked at 21 % LEL. For the hydrogen measurement, it is not possible to know the fraction of this measurement that is pure hydrogen versus cross-sensitivity with the presence of CO.

Figure 146 – C-side service door meter measurements during Test 3.

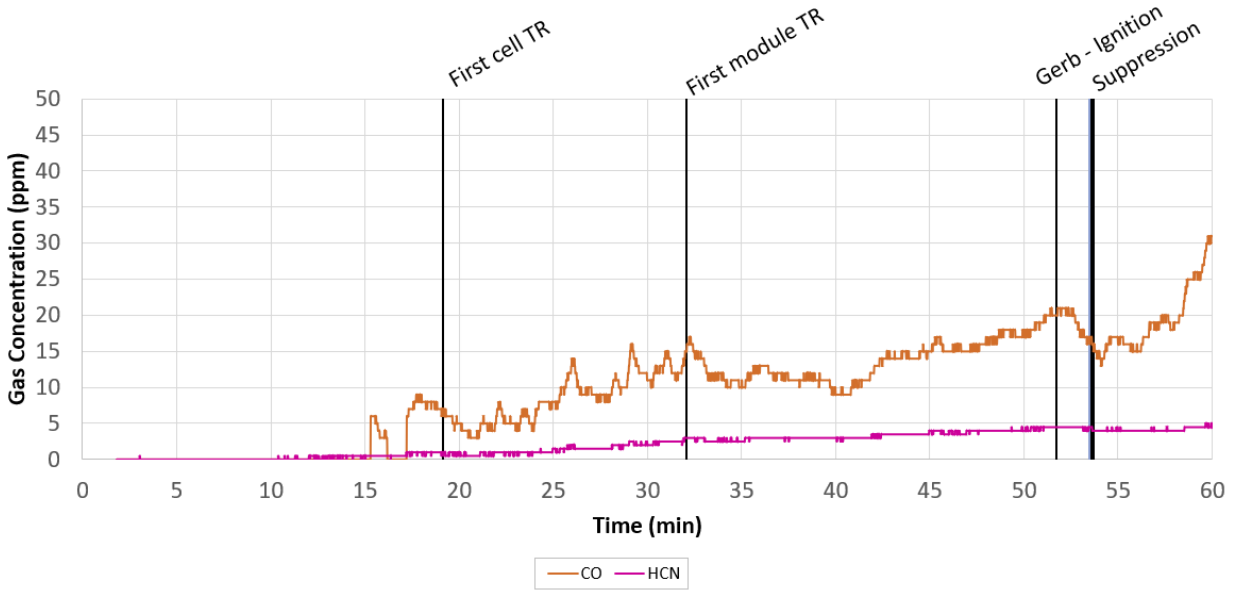
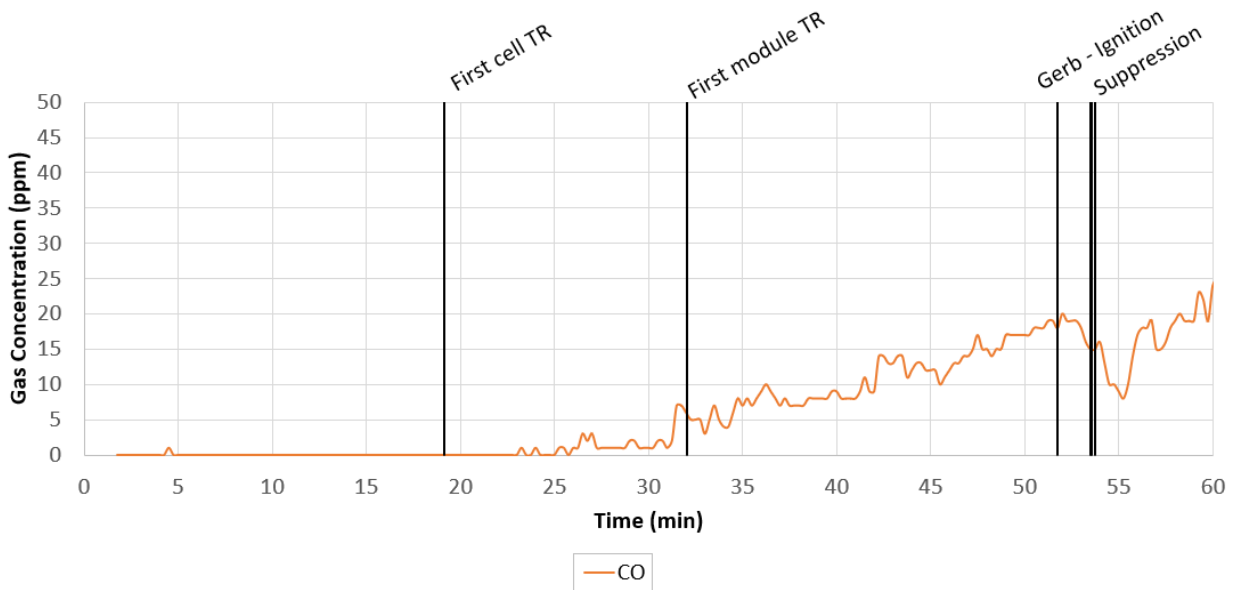
The two meters in the driveway showed parallel trends to each other, as plotted in Figure 148 and Figure 149. During the test, a steady increase in CO was registered by both driveway meters. A similarly steady increase in HCN was registered in the driveway meter at 20 ft (Figure 148). These increases were due to products of combustion from the test diffusing into the lab space and may not be fully representative of measurements in an unconfined environment. In an unconfined environment, lower concentration conditions would likely be present.

Figure 148 – Portable meter measurements at driveway 20 ft location during Test 3.

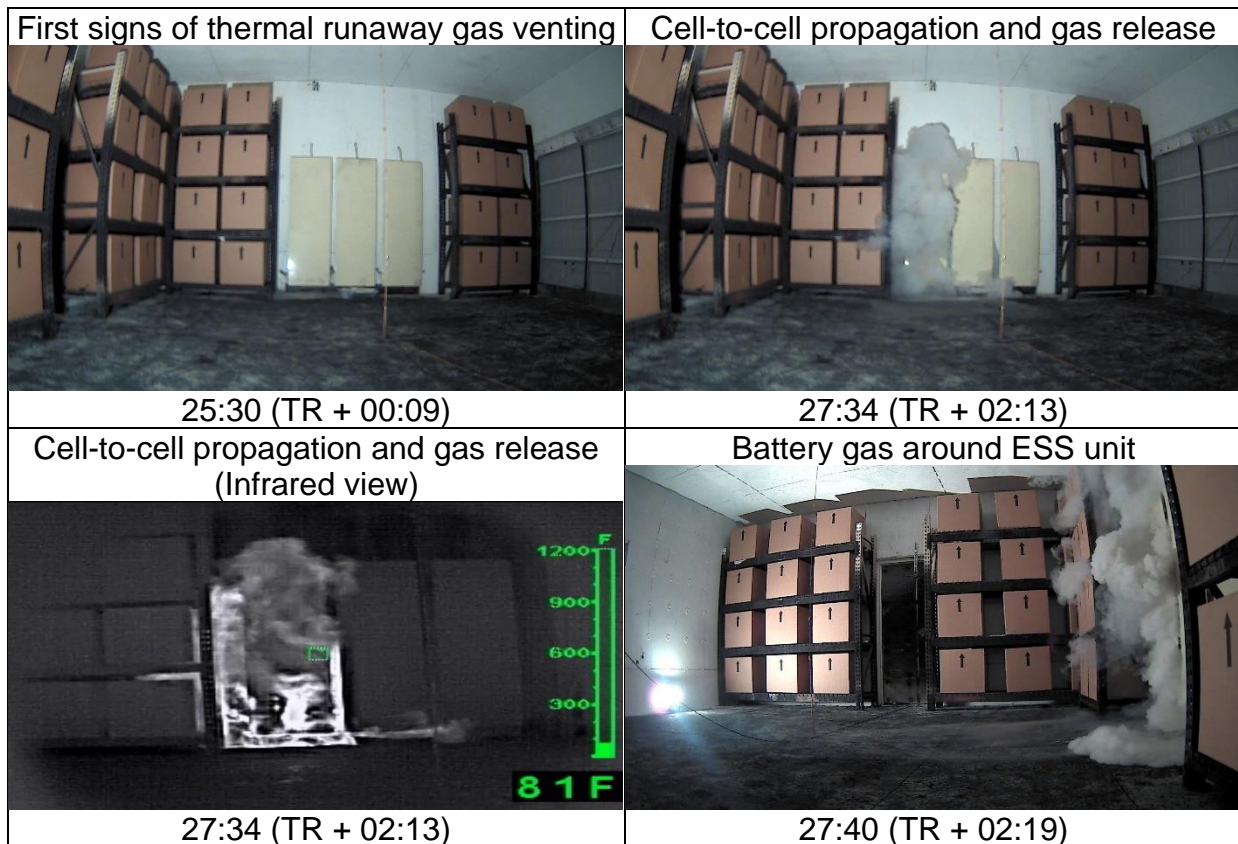
Test four was initiated by heating one 18650 component cell (“Unit1Init1_Cell1”) near the bottom of the leftmost ESS unit at 6°C/min for 25 minutes and 21 seconds, at which time thermal runaway occurred in the cell. Battery thermal runaway effluent gases were first observed external to the unit 9 seconds later, as pictured in Figure 150. Approximately 2 minutes later, cell-to-cell thermal runaway propagation was observed by sharp temperature increase within the initiating module (“Unit1Init1”). Ten seconds later, an increase in gas release and thermal signature in Unit 1 was observed. Gas evolved from Unit 1 and accumulated around Unit 1 and all tiers of the adjacent rack of Group A commodity boxes.

Figure 150 – Test events between 25 and 28 minutes of Test 4.

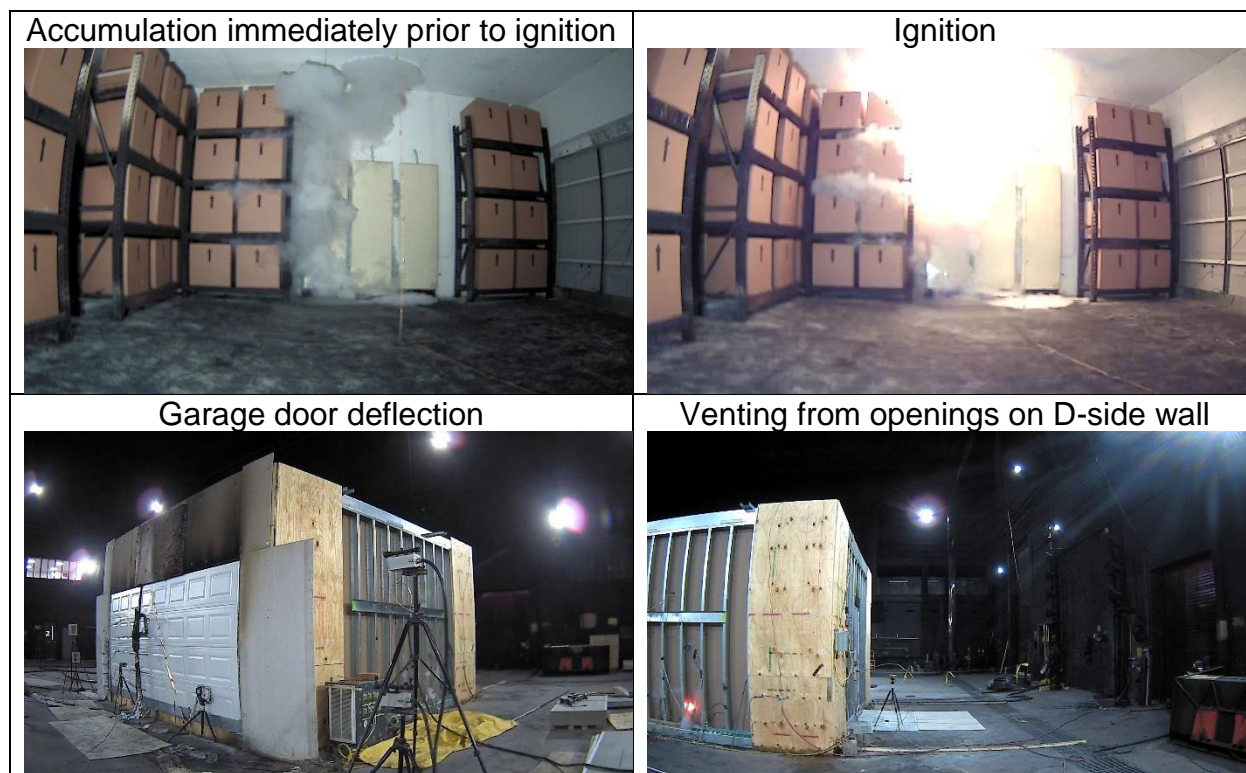
At 27 minutes and 41 seconds, 21 seconds after cell-to-cell propagation was observed, a gerb was activated to ignite the accumulated battery gases, as shown in Figure 151. This was intended to create an early ignition scenario, since Test 2 demonstrated that the batteries can generate viable ignition sources. The ignition of the battery gas resulted in a partial volume deflagration where the garage door was observed to bow out an

estimated 2 inches. Gas and flame were observed venting under pressure from conduit openings on the D-side wall. The garage exterior showed no further evidence from the deflagration 2 seconds later.

Figure 151 – Battery gas ignition at 27:41 (TR + 02:20).

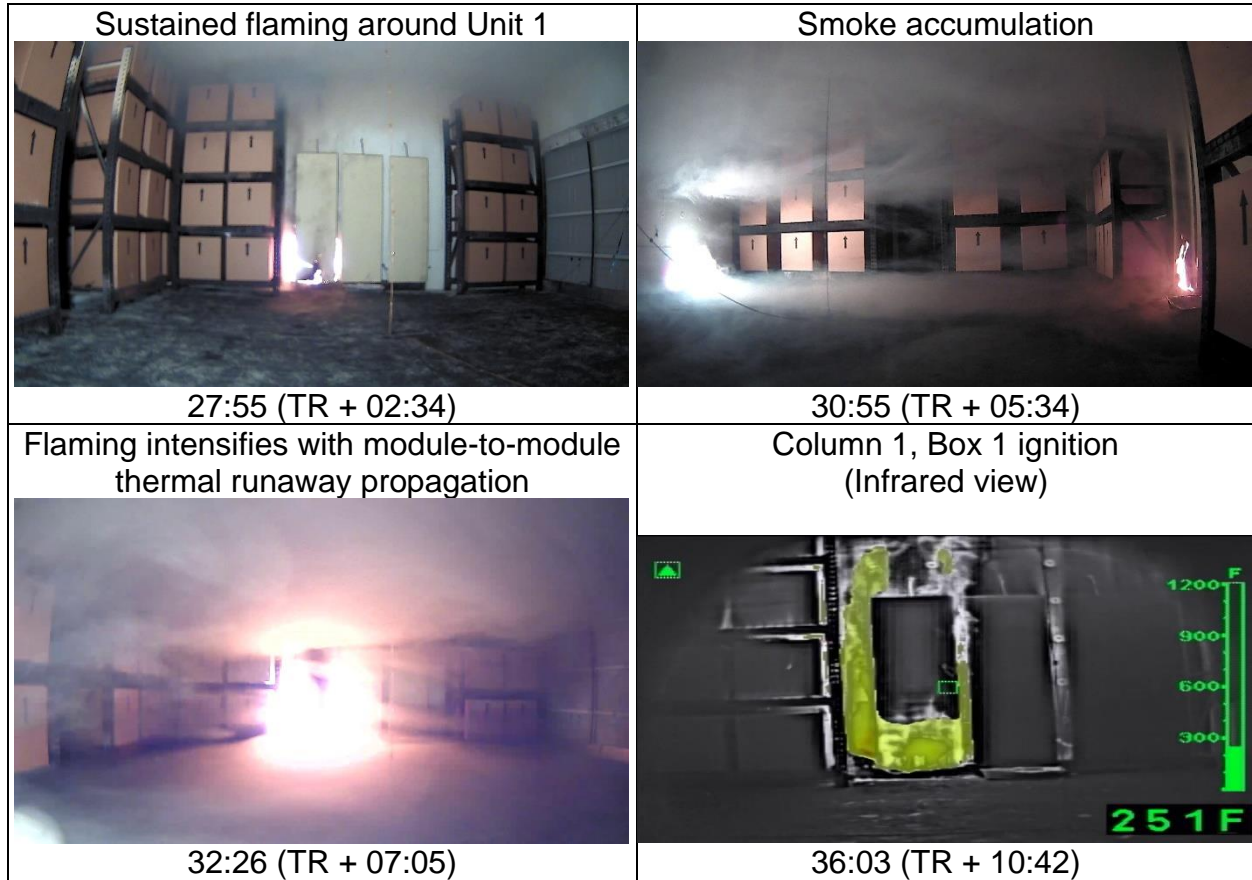
Sustained flaming was established around Unit 1, as pictured in Figure 152. A smoke layer accumulated near the ceiling with additional battery gas accumulating along the floor. Flaming intensified around 32 minutes as more batteries entered thermal runaway. The first confirmed module-to-module propagation occurred directly above the initiating module (“Unit1Init2”) at 32 minutes and 25 seconds.

Module-to-module propagation continued through Unit 1. During the one-minute span between 35 minutes and 36 minutes, thermal runaway was measured by sharp, sustained temperature increases in all instrumented modules in Unit 1. At approximately 36 minutes, the Group A commodity boxes began to ignite, starting with the column nearest Unit 1.

Figure 152 – Test events between 27 and 36 minutes in Test 4.

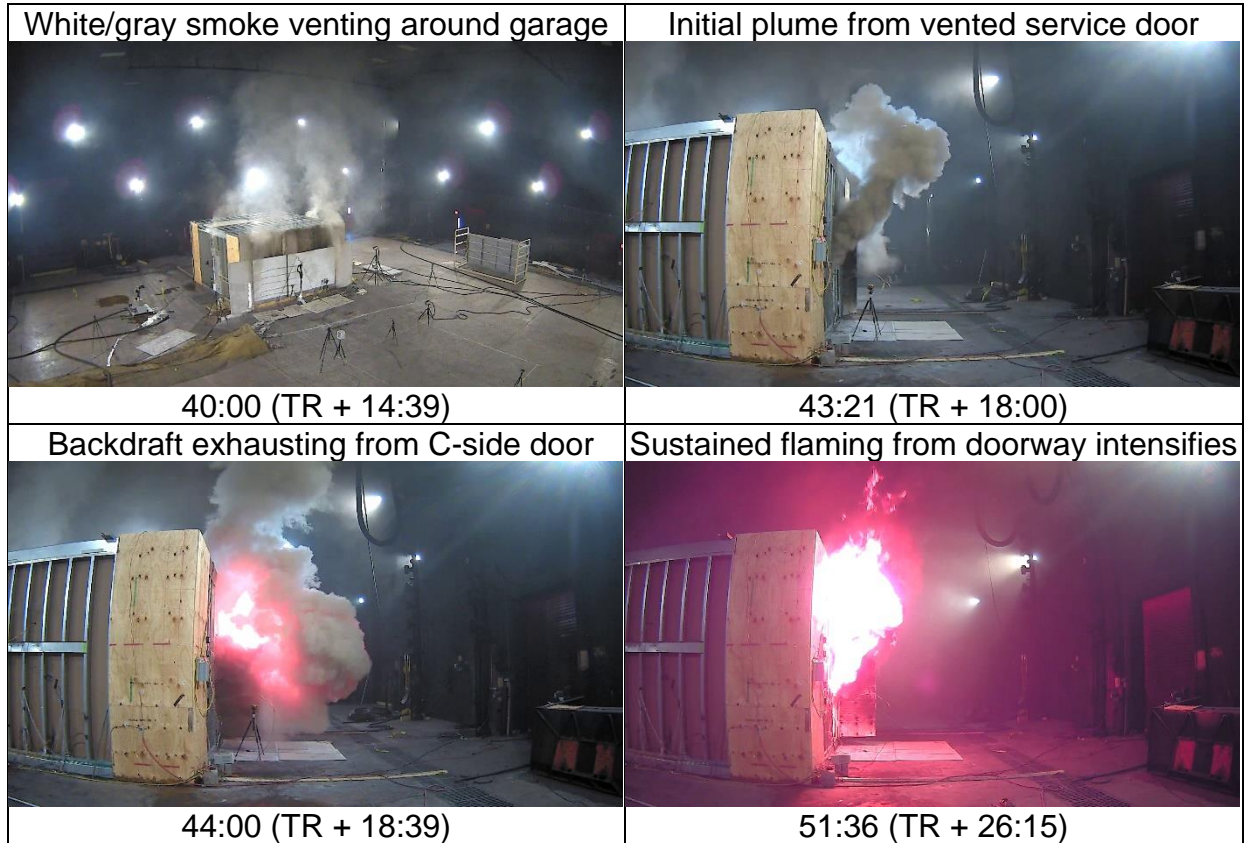
Fire department vent operations were simulated at 43 minutes and 21 seconds based on an established condition of ventilation-limited fire with battery gas contribution to the accumulated hot gas layer. Vent operation began with remote operation of the C-side door which simulated fire department response to an attached garage via the residence. A light gray plume of gas exhausted from the doorway. The garage door vent was not activated during Test 4 ventilation.

The influx of fresh air to the garage from the open door resulted in sustained flaming conditions inside the garage with Group A commodity boxes igniting. Near 46 minutes, batteries within Unit 2 underwent thermal runaway and contributed to fire growth. Thermal imaging shows the upper hot gas layer descending. Flaming intensified from the doorway as battery involvement increased.

Figure 153 – Test events between 40 and 52 minutes of Test 4.

Approximately 40 seconds after the remote operation of the C-side door and the subsequent influx of ambient air, a backdraft occurred which resulted in fire being ejected from the full height of the open door as shown in Figure 153. The event did not result in

any observable damage to the structure, but the ejected fire reached several feet out the door.

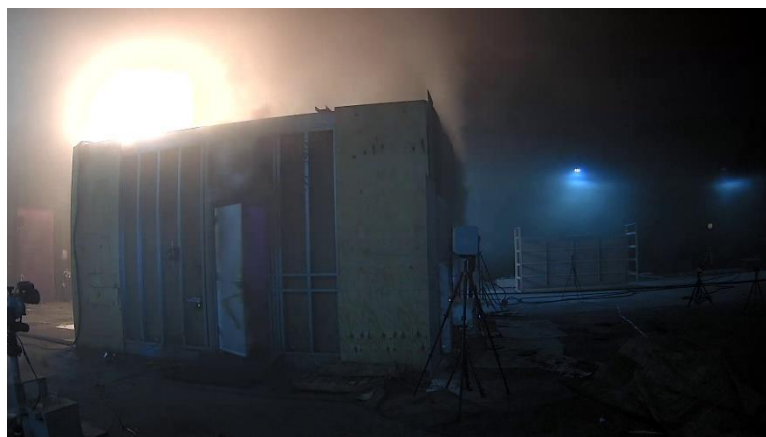
Test termination and suppression began at 54 minutes with remote operation of the B-side door and remote water application for suppression, as pictured in Figure 154.

Figure 154 – Conditions at test termination (54 minutes) in Test 4.

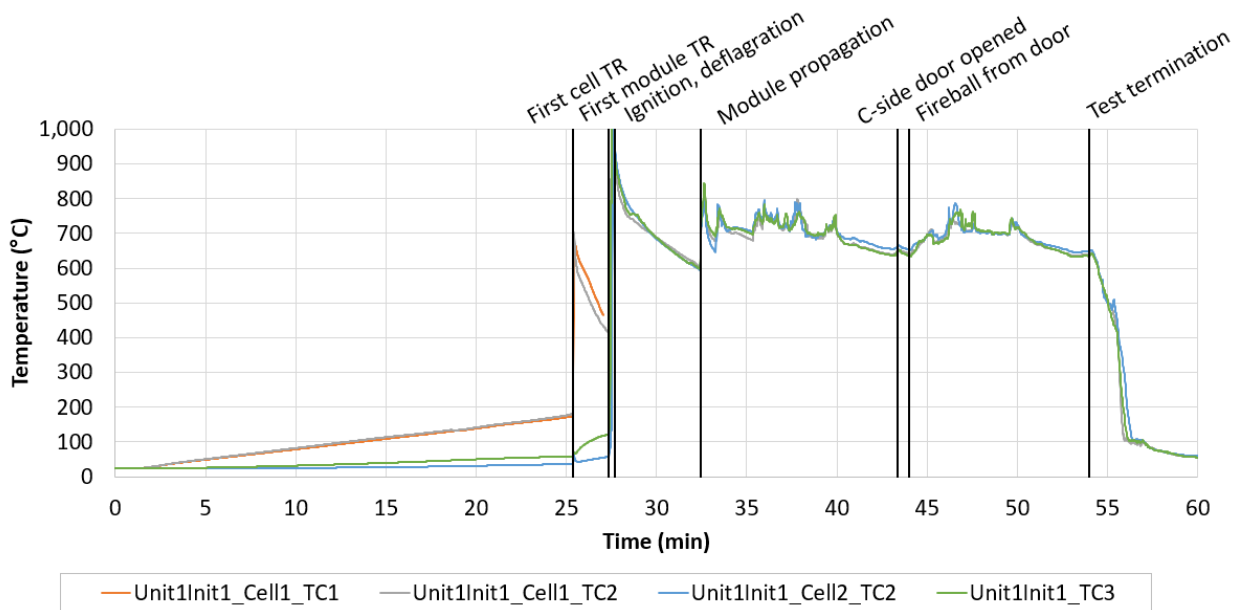
and heater operation was discontinued. Thermal runaway propagation through the rest of the cells in this module (“Unit1Init1”) occurred 3 minutes later, as shown in Figure 155.

Figure 155 – Temperature measurements in the initiating battery module (“Unit1Init1”).

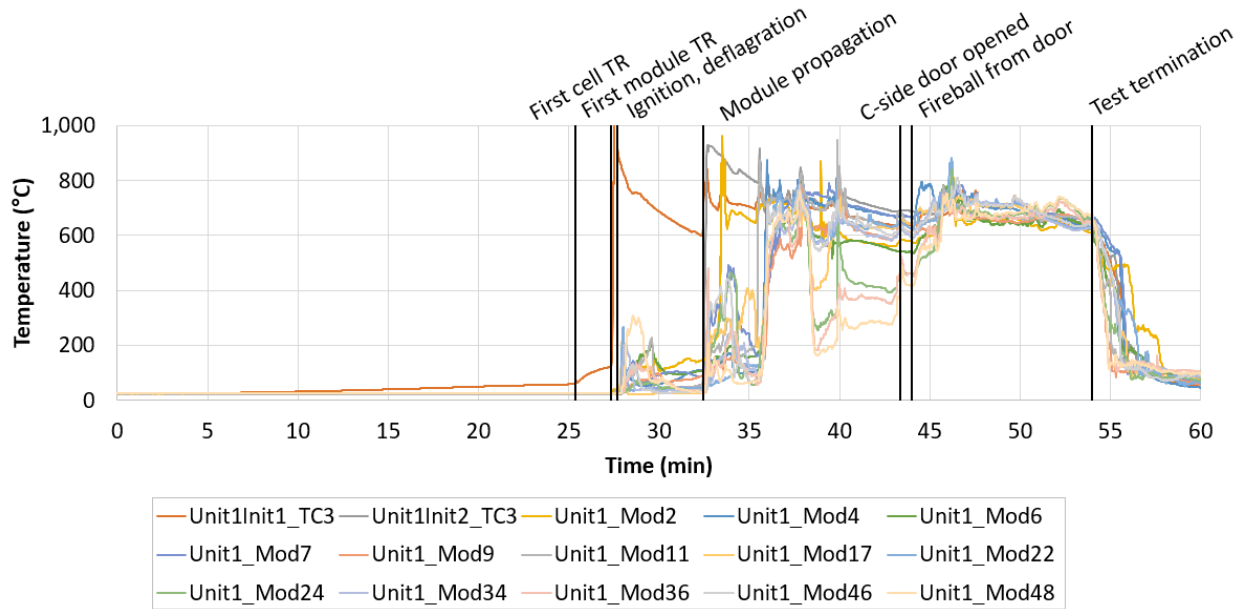
Twenty-one seconds after propagation within the first module, the accumulated battery vent gases were ignited. Five minutes later, at 32 minutes and 25 seconds of test time, module-to-module propagation was confirmed in the module directly above the initiating module (“Unit1Init2”). The next confirmed thermal runaway occurred in the module directly below the initiating module (“Unit1_Mod2”) within one minute. During the one-minute span between 35 minutes and 36 minutes, thermal runaway was measured by sharp, sustained temperature increases in all instrumented modules in Unit 1, as illustrated in Figure 156.

Figure 156 – Temperature measurements within the initiating unit (Unit 1) of Test 4.
