FIRE RESEARCH AND DEVELOPMENT TECHNICAL REPORT

Considerations for Fire Service Response to Residential Battery Energy Storage System Incidents

December 4, 2023

Prepared for the International Association of Fire Fighters

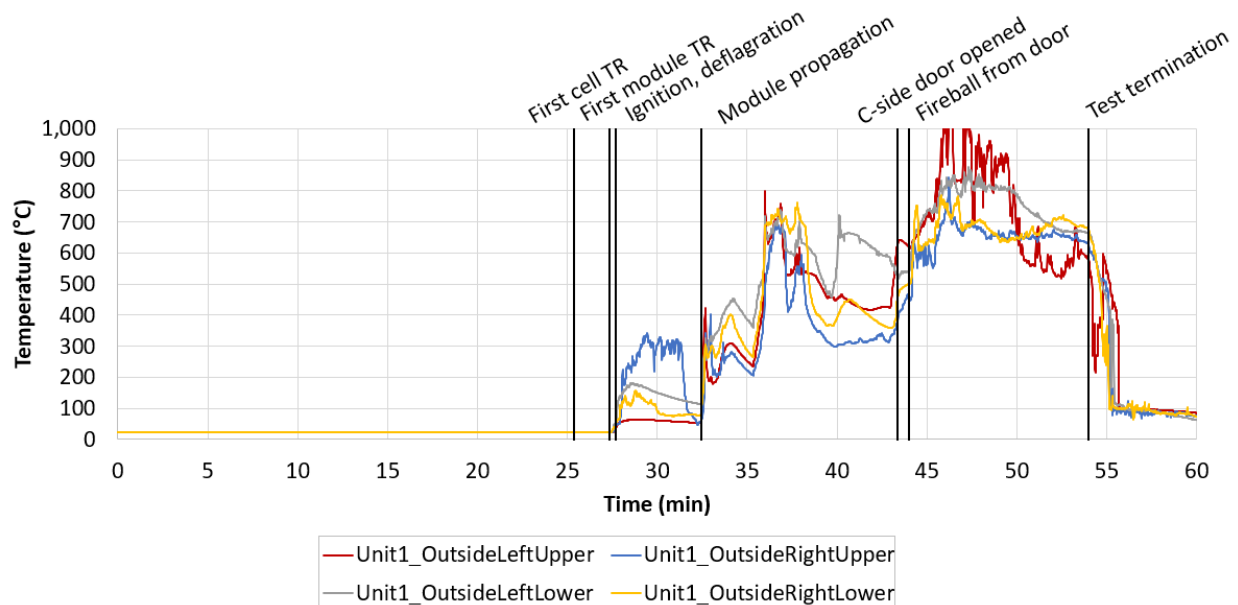
Temperature around the enclosure perimeter of Unit 1 did not increase from the first cell thermal runaway. Following ignition, sustained flaming was observed on the lower half of Unit 1. During this time, enclosure perimeter temperatures measured between 100 °C and 200 °C on the lower half and 50 °C to 300 °C on the upper half, as plotted in Figure 157. Module-to-module propagation resulted in increasing fire size and corresponding higher enclosure perimeter temperatures. Peak enclosure temperatures on Unit 1 prior to garage ventilation operations measured near 700 °C. This peak temperature occurred following the period of accelerated thermal runaway between 35 and 36 minutes through the majority of Unit 1.

Figure 157 – Unit 1 enclosure exterior temperatures in Test 4.

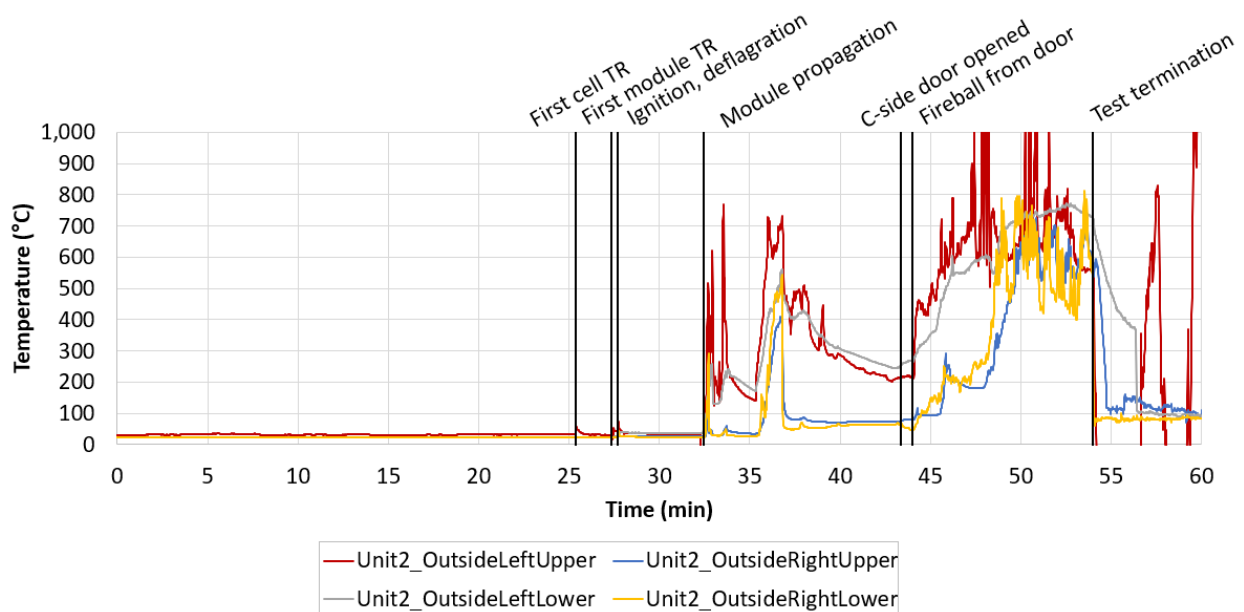
Enclosure perimeter temperatures on Unit 2 increased momentarily, not exceeding 100 °C, with the first cell thermal runaway and propagation through the initiating module, as shown in Figure 158. Temperatures on the left side of Unit 2, nearest to Unit 1, increased following module-to-module propagation in Unit 1. A spike in temperature exceeding 500 °C was observed on both sides of Unit 2 following the period of accelerated thermal runaway and fire growth from Unit 1 at 35 to 36 minutes.

Figure 158 – Unit 2 enclosure exterior temperatures in Test 4.

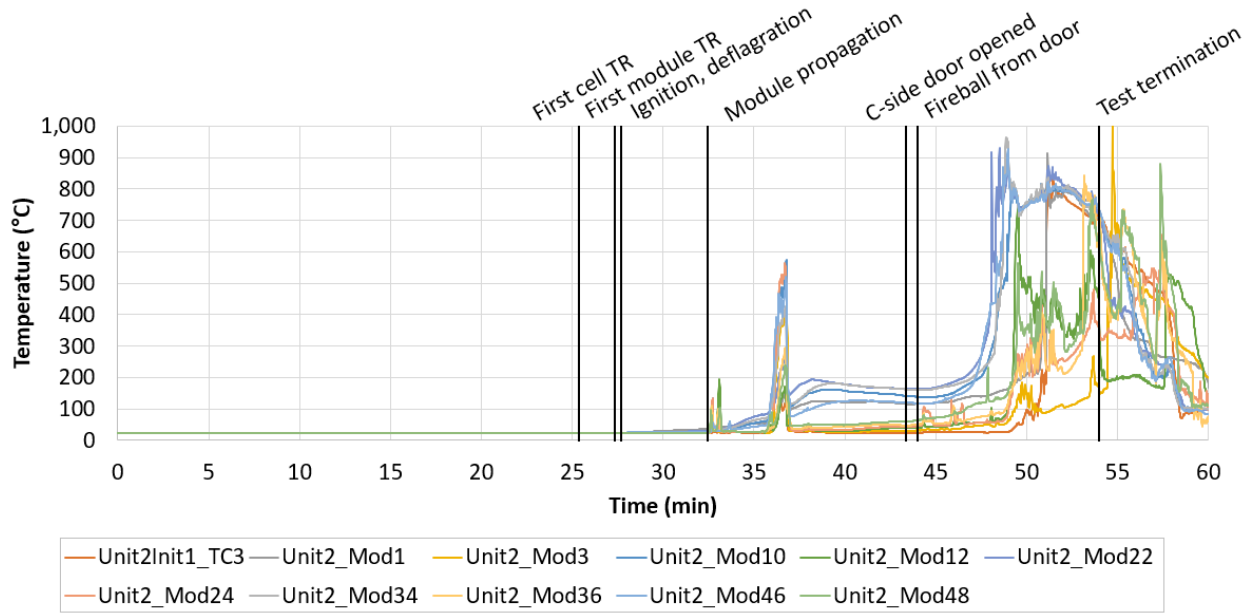
Near 46 minutes, thermal runaway behavior was observed within Unit 2 which resulted in sustained elevated temperatures between 600 and 800 °C on the outer enclosure of Unit 2. This is aligned with temperature trends within the modules of Unit 2 as illustrated by Figure 159. Thermal runaway was identified in the modules by a sharp, sustained increase in module temperature.

Figure 159 – Temperature measurements within the center unit (Unit 2) of Test 4.

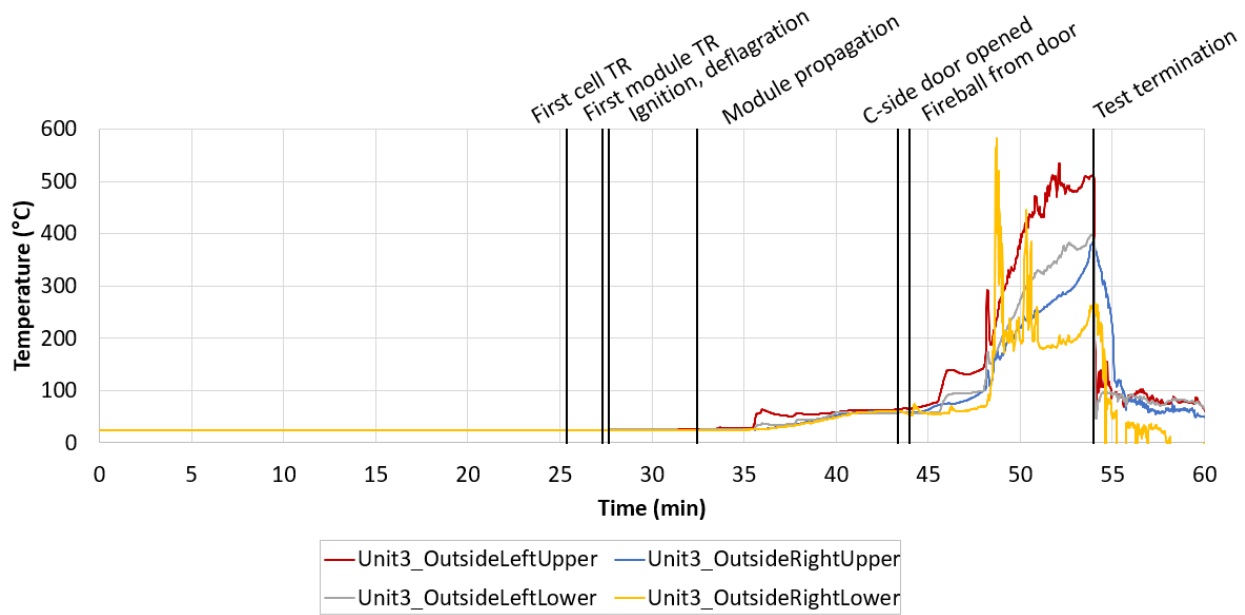
Exterior enclosure temperatures on the rightmost unit, Unit 3, did not show any significant temperature increase above ambient until Unit 1 module-to-module propagation began, as shown in Figure 160. During the period of module-to-module propagation and ventilation of the C-side door, enclosure temperatures for Unit 3 did not exceed 80 °C (which is below the cell venting threshold temperature). Most temperatures measured within the modules of Unit 3 (Figure 161) did not show thermal runaway temperature signatures for the duration of Test 4. However, one instrumented module (“Unit3_Mod34”) had a rapid increase in temperature with sustained temperature above 400 °C, which may have indicated thermal runaway.

Figure 160 – Unit 3 enclosure exterior temperatures in Test 4.

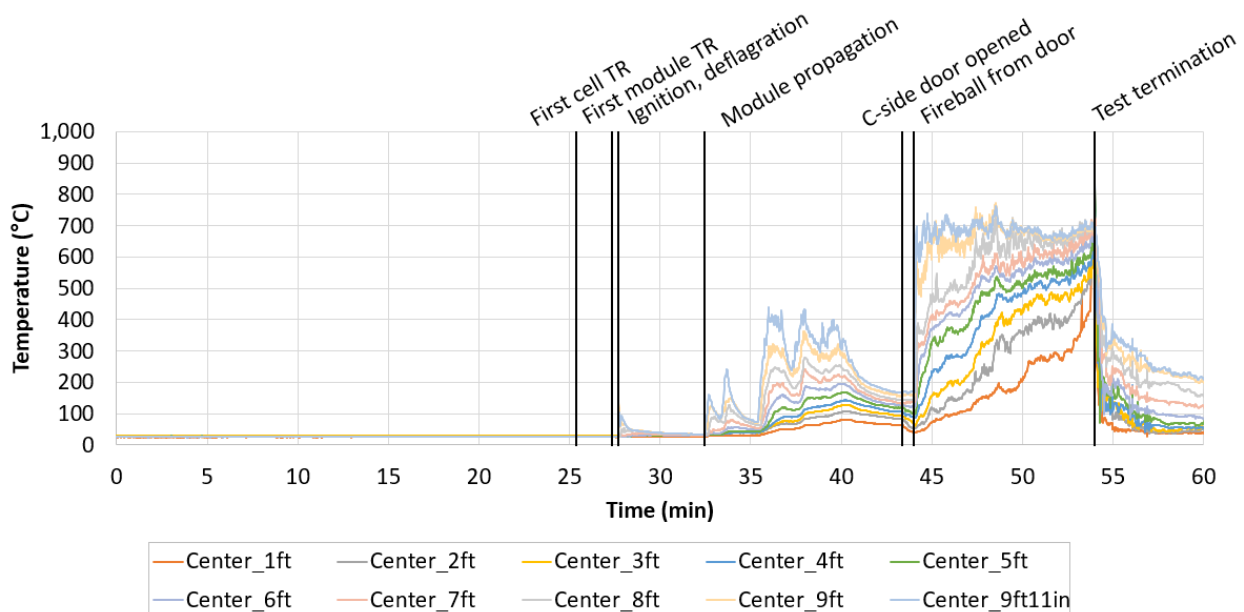
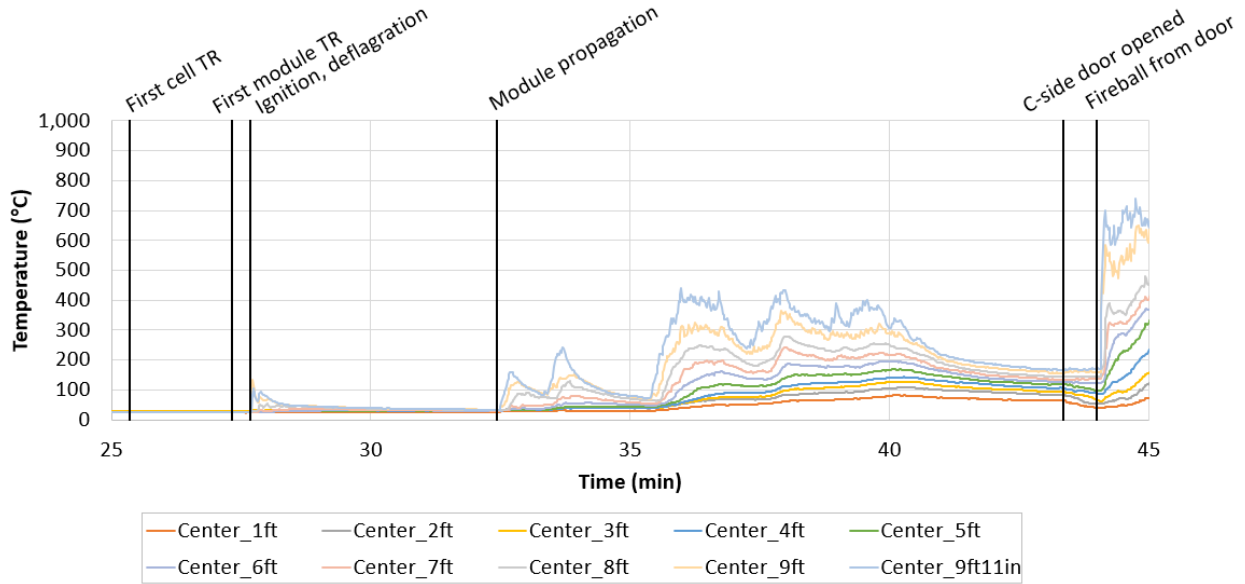
Gas temperatures measured in the center thermocouple array of the garage are plotted for the test duration in Figure 162 and for the period of greatest activity (25 to 45 minutes) in Figure 163.

Module-to-module propagation increased heat input to the compartment by venting hot gases and burning the flammable gases released. The garage interior temperature increased and decreased in parallel with increasing and decreasing thermal runaway frequency. When the Group A commodity boxes ignited at 36 minutes, temperatures increased to peak compartment temperatures at the ceiling of 400 °C. After 40 minutes and prior to ventilation of the C-side door, the garage fire became ventilation-limited, and temperatures decreased again.

Ventilation of the C-side door resulted in increased burning inside the garage. Temperatures rose rapidly at this point, resulting in flashover conditions with upper layer temperatures at the ceiling reaching 700 °C approximately 40 seconds after ventilation.

Test termination and remote suppression began at 54 minutes which resulted in an immediate temperature drop of 300-400 °C and a gradual decline to ambient afterwards.
